DEPARTMENT OF TRANSPORTATION

Quality Assurance and Source Inspection

Contract #: 04-0120F4Cty: SF/ALA Rte: 80 PM: 13.2/13.9File #: 69.28**WELDING INSPECTION REPORT****Resident Engineer:** Pursell, Gary**Address:** 333 Burma Road**City:** Oakland, CA 94607**Report No:** WIR-015517**Date Inspected:** 11-Jul-2010**Project Name:** SAS Superstructure**OSM Arrival Time:** 700**Prime Contractor:** American Bridge/Fluor Enterprises, a JV**OSM Departure Time:** 1900**Contractor:** Zhenhua Port Machinery Company, Ltd (ZPMC), Changxing Island **Location:** Shanghai, China**CWI Name:** Li Yang**CWI Present:** Yes No**Inspected CWI report:** Yes No N/A**Rod Oven in Use:** Yes No N/A**Electrode to specification:** Yes No N/A**Weld Procedures Followed:** Yes No N/A**Qualified Welders:** Yes No N/A**Verified Joint Fit-up:** Yes No N/A**Approved Drawings:** Yes No N/A**Approved WPS:** Yes No N/A**Delayed / Cancelled:** Yes No N/A**Bridge No:** 34-0006**Component:** OBG Segment**Summary of Items Observed:**

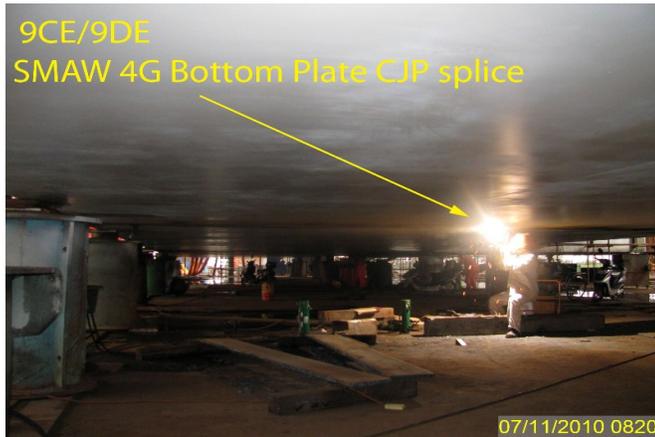
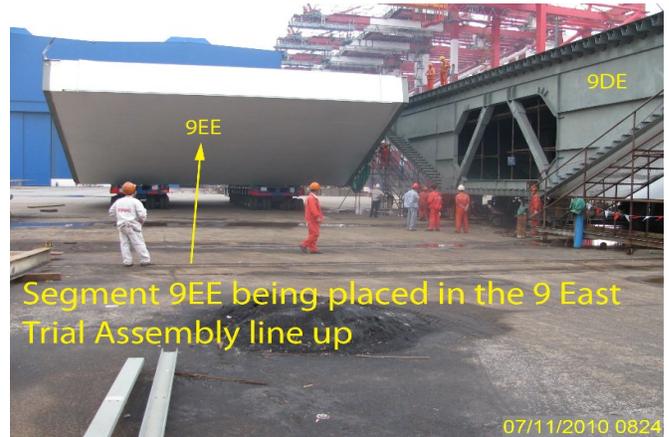
This QA Inspector observed Shielded Metal Arc Welding (SMAW) in progress of a Complete Joint Penetration (CJP) weld joint. The Weld joint is designated as OBE9C-003, Bottom Plate splice. The welders are identified as #037932, 067765 and 066179 and were observed welding in the 4G (overhead) position using approved Welding Procedure Specification WPS-B-P-2214-B-U2-FCM-1.

This QA Inspector observed segment 9EE being placed in the 9 East trial assembly line up.
