Quality Assurance and Source Inspection

Contract #: 04-0120F4Cty: SF/ALA Rte: 80 PM: 13.2/13.9File #: 1.28**WELDING INSPECTION REPORT****Resident Engineer:** Pursell, Gary**Address:** 333 Burma Road**City:** Oakland, CA 94607**Report No:** WIR-015565**Date Inspected:** 12-Jul-2010**Project Name:** SAS Superstructure**OSM Arrival Time:** 700**Prime Contractor:** American Bridge/Fluor Enterprises, a JV**OSM Departure Time:** 1530**Contractor:** American Bridge/Fluor Enterprises, a JV**Location:** Jobsite**CWI Name:** See below**CWI Present:** Yes No**Inspected CWI report:** Yes No N/A**Rod Oven in Use:** Yes No N/A**Electrode to specification:** Yes No N/A**Weld Procedures Followed:** Yes No N/A**Qualified Welders:** Yes No N/A**Verified Joint Fit-up:** Yes No N/A**Approved Drawings:** Yes No N/A**Approved WPS:** Yes No N/A**Delayed / Cancelled:** Yes No N/A**Bridge No:** 34-0006**Component:** SAS OBG**Summary of Items Observed:**

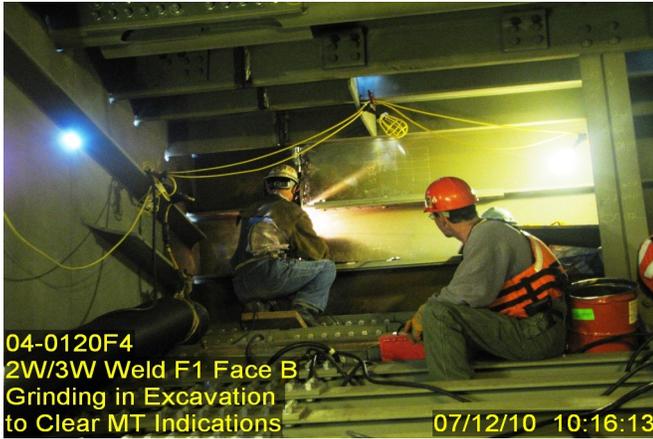
The QAI periodically observed AB/F personnel performing air carbon arc gouging and grinding to repair the inside gouged groove on OBG Field Splice 2W/3W Weld ID: F1. SE QC Inspector Tom Pasqualone performed

MT of the repaired areas and marked up additional areas for repairs. The performance and evaluation of the MT appeared to comply with the MT procedure identified as SE-MT-CT-D1.5-101 Rev. 4. Several iterations of intermittent inspection and repair work were observed throughout the shift. See photo below. The work at this location was not completed during this shift. The work at this location was not completed during this shift.

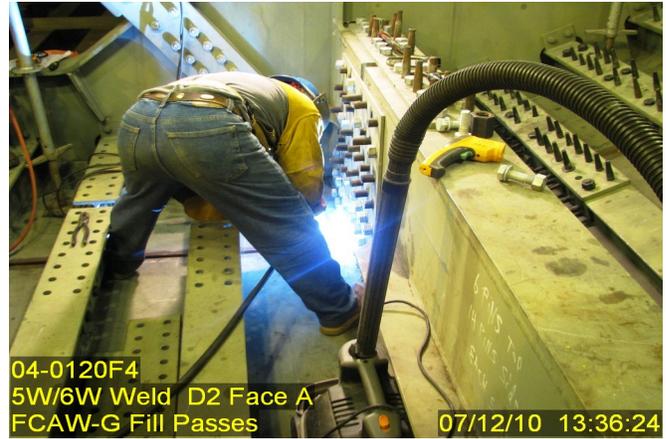
The QAI periodically observed the in process welding of the full length tack welds to seal the bevel face to the steel backing in the OBG Field Splice 5W/6W weld ID: D1 & D2 Face A per the Flux Cored Welding (FCAW-G) process in the 2F (horizontal) position by AB/F approved welding personnel Xiao Jian Wan (ID 9677). The QC Inspector Bonafacio Daquinag was present to monitor the progress and verify that the welding parameters were within the limits established by the approved welding Procedure Specification (WPS) identified as ABF-WPS-D1.5-F3200-2. Welding of the full length tack welds at this location was completed on this date and appeared to be in general compliance with contract documents. After the lunch break the QAI periodically observed the in process welding of the fill passes in the last 460mm (from Y=3790mm to Y=4250mm) of the OBG Field Splice 5W/6W weld ID: D2, Face A per the FCAW-G process in the 1G (flat) position by AB/F approved welding personnel Xiao Jian Wan (ID 9677). The QC Inspector Bonafacio Daquinag was present to monitor the progress and verify that the welding parameters were within the limits established by the approved welding Procedure Specification (WPS) identified as ABF-WPS-D1.5-3040A-1. Welding of the fill passes was in process for the remainder of the QA Inspectors shift and appeared to be in general compliance with contract documents. See photo below.
