Quality Assurance and Source Inspection

Contract #: 04-0120F4Cty: SF/ALA Rte: 80 PM: 13.2/13.9File #: 1.28**WELDING INSPECTION REPORT****Resident Engineer:** Pursell, Gary**Address:** 333 Burma Road**City:** Oakland, CA 94607**Report No:** WIR-015642**Date Inspected:** 15-Jul-2010**Project Name:** SAS Superstructure**OSM Arrival Time:** 700**Prime Contractor:** American Bridge/Fluor Enterprises, a JV**OSM Departure Time:** 1530**Contractor:** American Bridge/Fluor Enterprises, a JV**Location:** Jobsite**CWI Name:** See below**CWI Present:** Yes No**Inspected CWI report:** Yes No N/A**Rod Oven in Use:** Yes No N/A**Electrode to specification:** Yes No N/A**Weld Procedures Followed:** Yes No N/A**Qualified Welders:** Yes No N/A**Verified Joint Fit-up:** Yes No N/A**Approved Drawings:** Yes No N/A**Approved WPS:** Yes No N/A**Delayed / Cancelled:** Yes No N/A**Bridge No:** 34-0006**Component:** SAS OBG**Summary of Items Observed:**

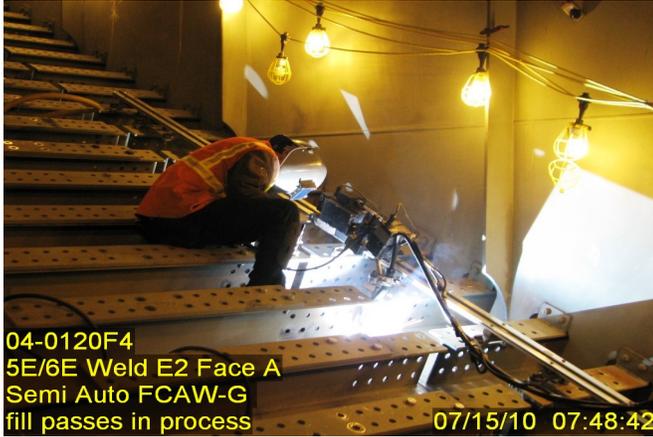
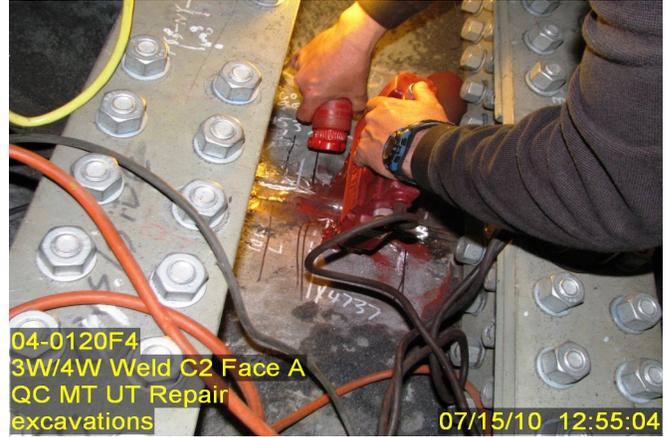
The QAI periodically observed in process welding of OBG Field Splice 5E/6E Weld ID: E2, from Face A per the Semi-Automated FCAW-G process in the 3G (vertical) position. The welding was performed by AB/F approved welder Song Tao Huang (3794). The SE QC Inspector Bernard Docena was present to monitor the progress and verify that the welding parameters were within the limits established by the approved welding Procedure Specification (WPS) identified as ABF-WPS-D1.5-3042A-1. Welding of the fill and cover passes was in process during this shift. See photo below. Work at this location appeared to be in general compliance with contract documents.
