Contract #: 04-0120F4Cty: SF/ALA Rte: 80 PM: 13.2/13.9File #: 69.28**WELDING INSPECTION REPORT****Resident Engineer:** Pursell, Gary**Address:** 333 Burma Road**City:** Oakland, CA 94607**Report No:** WIR-015654**Date Inspected:** 16-Jul-2010**Project Name:** SAS Superstructure**OSM Arrival Time:** 700**Prime Contractor:** American Bridge/Fluor Enterprises, a JV**OSM Departure Time:** 1900**Contractor:** Zhenhua Port Machinery Company, Ltd (ZPMC), Changxing Island **Location:** Shanghai, China**CWI Name:** Li Yang and Zhu Zhong Hai**CWI Present:** Yes No**Inspected CWI report:** Yes No N/A**Rod Oven in Use:** Yes No N/A**Electrode to specification:** Yes No N/A**Weld Procedures Followed:** Yes No N/A**Qualified Welders:** Yes No N/A**Verified Joint Fit-up:** Yes No N/A**Approved Drawings:** Yes No N/A**Approved WPS:** Yes No N/A**Delayed / Cancelled:** Yes No N/A**Bridge No:** 34-0006**Component:** OBG Trial Assembly**Summary of Items Observed:**

Orthotropic Box Girder (OBG) Trial Assembly Areas

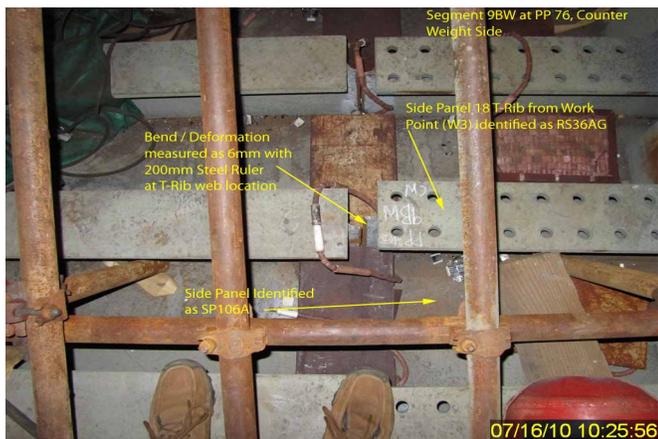
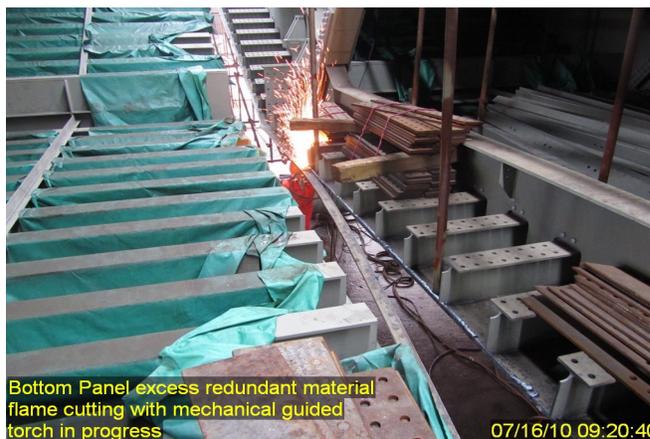
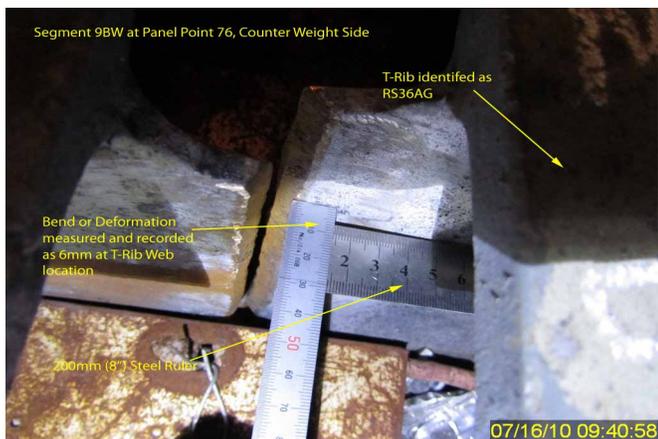
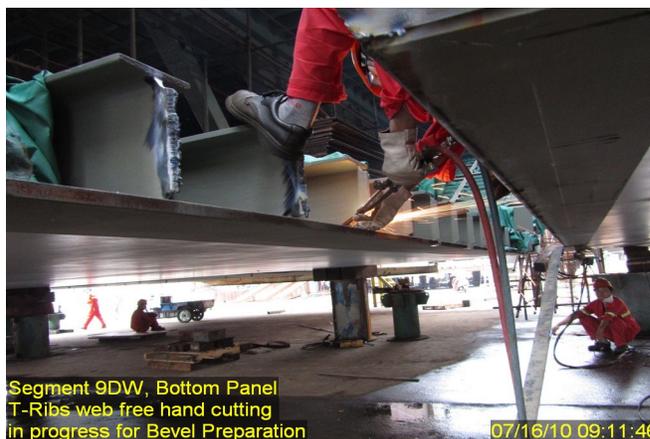
This Quality Assurance (QA) Inspector wrote an Incident Report for bend Side Panel T-Rib web for Segment 9BW at Panel Points (PP) 76. Please refer the Incident Report # 04-0120F4_TL-15_B278_07-16-2010_9BW_Side Panel_T-Rib_Counter Weight_Impact Damage dated July 16, 2010.

This QA Inspector observed that the ZPMC personnel were cutting the Bottom Panel using the mechanical guided flame cutting torch on the pre-scribed lines for Segment 9CW at Panel Point (PP) 79. Please reference the pictures attached for more comprehensive details. Please reference the pictures attached for more comprehensive details

This QA Inspector observed that the ZPMC personnel were cutting the Bottom Panel T-Rib web for bevel

preparation using the manual flame cutting torch for Segment 9DW at Panel Point (PP) 80. Please reference the pictures attached for more comprehensive details. A RFI was approved to allow free hand cutting for a length up to 300mm.
