**DEPARTMENT OF TRANSPORTATION**

Contract #: 04-0120F4Cty: SF/ALA Rte: 80 PM: 13.2/13.9File #: 1.28**WELDING INSPECTION REPORT****Resident Engineer:** Pursell, Gary**Address:** 333 Burma Road**City:** Oakland, CA 94607**Report No:** WIR-015764**Date Inspected:** 21-Jul-2010**Project Name:** SAS Superstructure**OSM Arrival Time:** 900**Prime Contractor:** American Bridge/Fluor Enterprises, a JV**OSM Departure Time:** 1730**Contractor:** American Bridge/Fluor Enterprises, a JV**Location:** Job Site

# WELDING INSPECTION REPORT

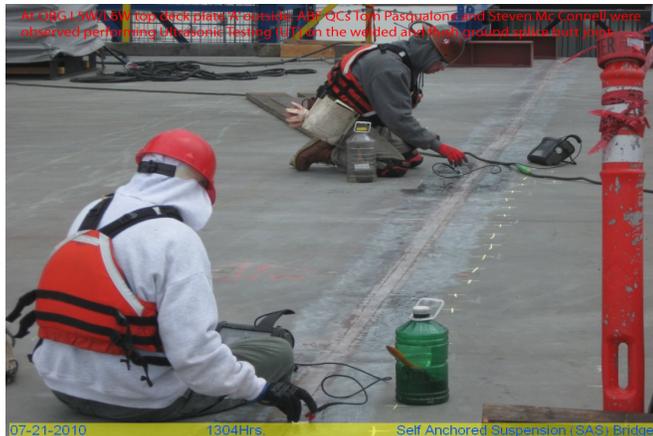
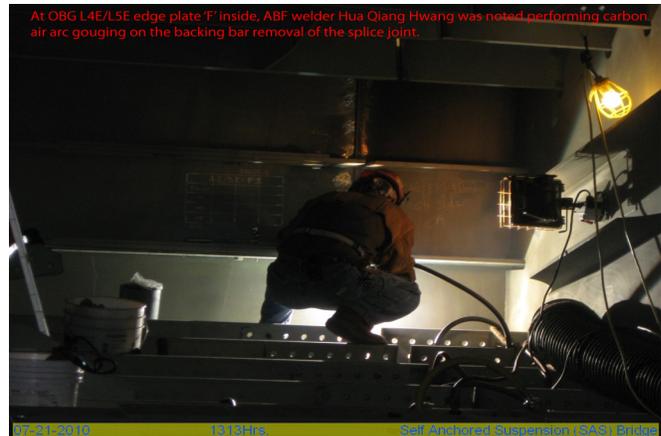
At OBG L4E/L5E edge plates 'B' and 'F' inside, two ABF welders Hua Qiang Hwang and Jin Pei Wang were noted air arc gouging separately on the edge plate backing bar removal. During the shift, welder Hua Qiang Hwang has completed the air arc gouging and started grinding the groove of the gouged plate. The other welder has continued gouging until the end of the shift and was not able to complete.
