Contract #: 04-0120F4Cty: SF/ALA Rte: 80 PM: 13.2/13.9File #: 1x.28**WELDING INSPECTION REPORT****Resident Engineer:** Pursell, Gary**Address:** 333 Burma Road**City:** Oakland, CA 94607**Report No:** WIR-015952**Date Inspected:** 26-Jul-2010**Project Name:** SAS Superstructure**OSM Arrival Time:** 700**Prime Contractor:** American Bridge/Fluor Enterprises, a JV**OSM Departure Time:** 1100**Contractor:** American Bridge/Fluor Enterprises, a JV**Location:** Job Site**CWI Name:** John Pagliero**CWI Present:** Yes No**Inspected CWI report:** Yes No N/A**Rod Oven in Use:** Yes No N/A**Electrode to specification:** Yes No N/A**Weld Procedures Followed:** Yes No N/A**Qualified Welders:** Yes No N/A**Verified Joint Fit-up:** Yes No N/A**Approved Drawings:** Yes No N/A**Approved WPS:** Yes No N/A**Delayed / Cancelled:** Yes No N/A**Bridge No:** 34-0006**Component:** OBG Section**Summary of Items Observed:**

WELDING INSPECTION REPORT

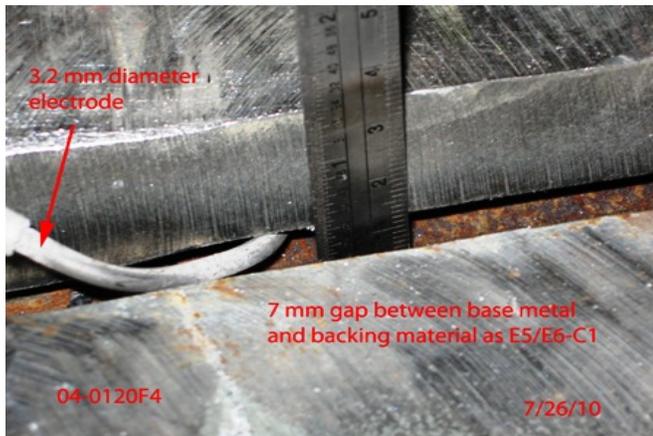
At weld joint E5/E6-C2 this QA Inspector observed welding had not been performed but that the fit up of the weld joint had been marked acceptable by QC personnel, 7/19/19, adjacent to the weld joint. This QA Inspector

performed a random visual verification of the fit up and observed a 7 mm gap between the base metal and the backing material for approximately 750 mm in length, starting at the 2500mm mark. See photo of gap below. This QA Inspector informed QC Inspector John Pagliero of this discovery. This QA Inspector was informed by ABF welding personnel Songtao Huang (# 3794) a wedge from the fitting dogs on the outside had fallen out. QC Inspector John Pagliero stated the fit up would be re-inspected prior to any welding.
