**DEPARTMENT OF TRANSPORTATION**

Contract #: 04-0120F4Cty: SF/ALA Rte: 80 PM: 13.2/13.9File #: 1.28**WELDING INSPECTION REPORT****Resident Engineer:** Pursell, Gary**Address:** 333 Burma Road**City:** Oakland, CA 94607**Report No:** WIR-015959**Date Inspected:** 30-Jul-2010**Project Name:** SAS Superstructure**OSM Arrival Time:** 1000**Prime Contractor:** American Bridge/Fluor Enterprises, a JV**OSM Departure Time:** 1830**Contractor:** American Bridge/Fluor Enterprises, a JV**Location:** Job Site

# WELDING INSPECTION REPORT

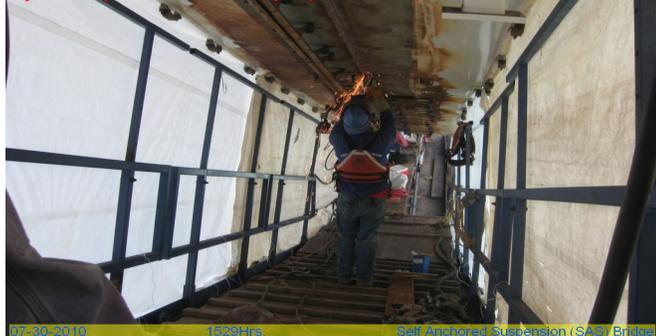
At OBG 4E/5E side plate 'C' outside, ABF personnel was seen grinding the indications noted during the Magnetic Particle Testing performed by QC. The ground groove surface of the joint was rejected by ABF QC Jesse Cayabyab due to presence of indications.

1. At OBG 4E/5E side plate 'C' outside, ABF QC Jesse Cayabyab informed this QA that he performed the Magnetic Particle Testing (MT) on the groove of the ground and gouged surface of the backing bar removal of the splice joint. According to QC, he still found presence of slag and that he rejected the ground surface backing bar removal.

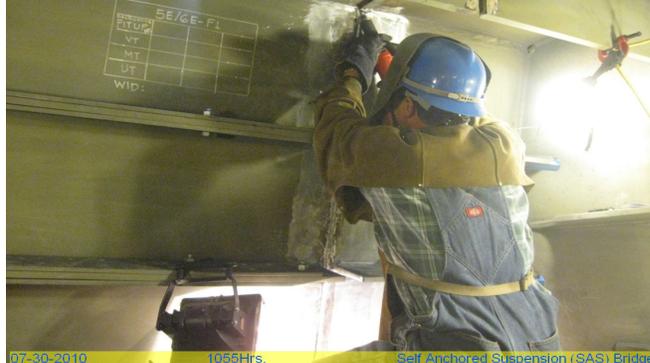
At OBG 5E/6E edge plate 'F' inside, ABF welder Jin Pei Wang was noted grinding the groove of the gouged backing bar removal of the splice butt joint using a die grinder.

At OBG 5E/6E edge plate 'F' inside, QA observed ABF welder Jin Pei Wang perform grinding on the groove of the gouged backing bar removal. During the shift, the welder has completed grinding the groove of the backing bar removal and has moved to edge plate 'B' of the same OBG. The welder performed the same task of grinding the groove of the gouged backing bar removal until the end of the shift.

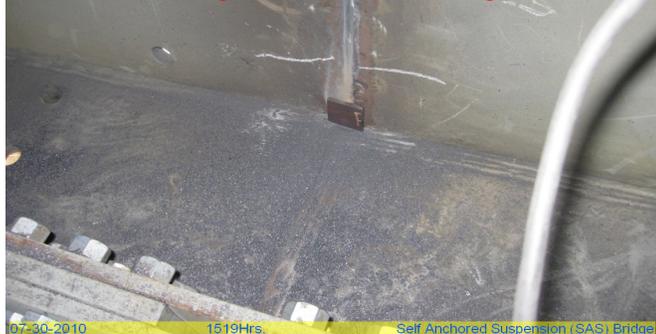
At OBG 4E/5E edge plate 'B' inside, a backing bar was attached to the bottom of the splice joint where welding was not completed due to limited access. The splice butt joint is now being welded from the outside using Shielded Metal Arc Welding.

2. At OBG 4E/5E edge plate 'B' outside, ABF QC Jesse Cayabyab also informed this QA that welder Jeremy Dolman was welding the open section of the splice joint located at the bottom. This QA went to the area where the welding was ongoing. Since there was a concern raised by fellow QA Craig Hager on how to weld the bottom of the splice with an opening, QA took a closer look on how ABF will proceed. It was noted during the time of welding that the welder cleaned up and transitioned the surface of the area to be welded, put a run off tab to the bottom and installed a backing bar from the inside. Previously, this has been the way ABF was doing and it is the same thing as what they are doing now.
