DEPARTMENT OF TRANSPORTATION

Contract #: 04-0120F4Cty: SF/ALA Rte: 80 PM: 13.2/13.9File #: 69.28**WELDING INSPECTION REPORT****Resident Engineer:** Pursell, Gary**Address:** 333 Burma Road**City:** Oakland, CA 94607**Report No:** WIR-016033**Date Inspected:** 02-Aug-2010**Project Name:** SAS Superstructure**OSM Arrival Time:** 700**Prime Contractor:** American Bridge/Fluor Enterprises, a JV**OSM Departure Time:** 1900**Contractor:** Zhenhua Port Machinery Company, Ltd (ZPMC), Changxing Island **Location:** Shanghai, China**CWI Name:** Mr. Lu xian ping**CWI Present:** Yes No**Inspected CWI report:** Yes No N/A**Rod Oven in Use:** Yes No N/A**Electrode to specification:** Yes No N/A**Weld Procedures Followed:** Yes No N/A**Qualified Welders:** Yes No N/A**Verified Joint Fit-up:** Yes No N/A**Approved Drawings:** Yes No N/A**Approved WPS:** Yes No N/A**Delayed / Cancelled:** Yes No N/A**Bridge No:** 34-0006**Component:** Orthotropic Box Girder (OBG)**Summary of Items Observed:**

This CALTRANS OSM Quality Assurance Inspector (QA) Surendra Prabhu was present during the times noted above for observations relative to the fabrication of the Self Anchored Suspension (SAS) Superstructure b

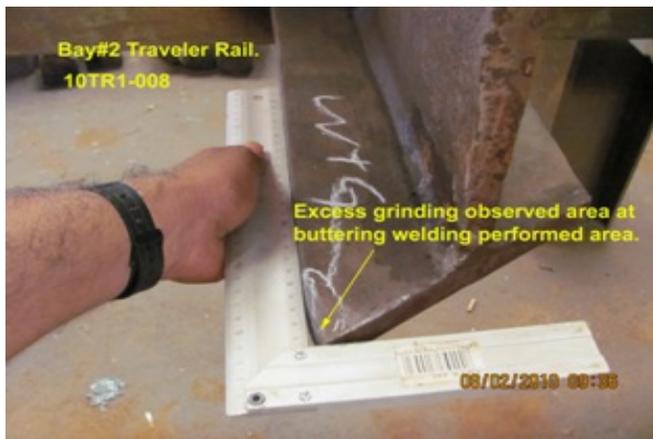
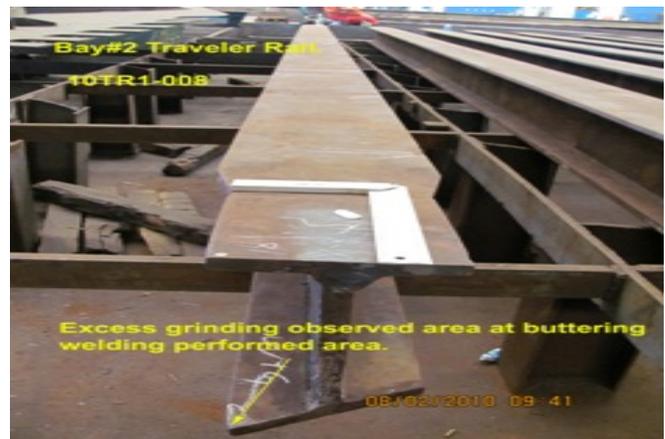
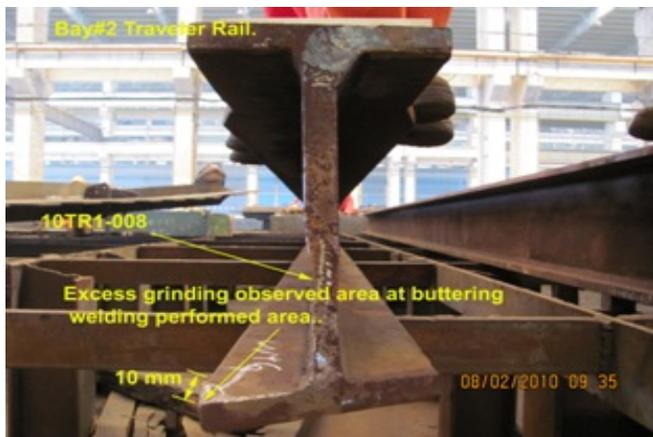
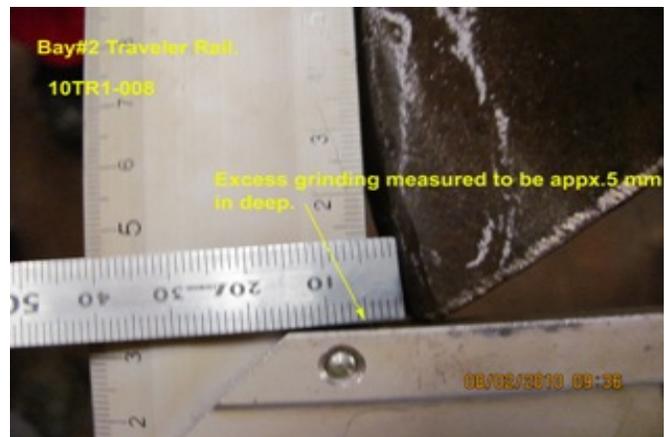
During dimensional inspection this QA Inspector observed the width of the flange has been reduced approximately 5 mm due to the excess grinding on the Traveler rail flange at end of the TR buttering welding performed area. The TR is identified as 10TR1-008. This QA marked the affected area and informed ZPMC Quality Control (QC) identified as Mr. Zhulin and American Bridge/Fluor (AB/F) QA Inspector Mr. Wang wen Bin of this issue. Mr. Zhulin and Mr. Wang wen Bin informed this QA that the flange width would be corrected in a manner compliant with the contract documents. Refer the attached photos for further information.
