Quality Assurance and Source Inspection

Contract #: 04-0120F4Cty: SF/ALA Rte: 80 PM: 13.2/13.9File #: 1.28**WELDING INSPECTION REPORT****Resident Engineer:** Pursell, Gary**Address:** 333 Burma Road**City:** Oakland, CA 94607**Report No:** WIR-016037**Date Inspected:** 02-Aug-2010**Project Name:** SAS Superstructure**OSM Arrival Time:** 700**Prime Contractor:** American Bridge/Fluor Enterprises, a JV**OSM Departure Time:** 1530**Contractor:** American Bridge/Fluor Enterprises, a JV**Location:** Jobsite**CWI Name:** See below**CWI Present:** Yes No**Inspected CWI report:** Yes No N/A**Rod Oven in Use:** Yes No N/A**Electrode to specification:** Yes No N/A**Weld Procedures Followed:** Yes No N/A**Qualified Welders:** Yes No N/A**Verified Joint Fit-up:** Yes No N/A**Approved Drawings:** Yes No N/A**Approved WPS:** Yes No N/A**Delayed / Cancelled:** Yes No N/A**Bridge No:** 34-0006**Component:** SAS OBG**Summary of Items Observed:**

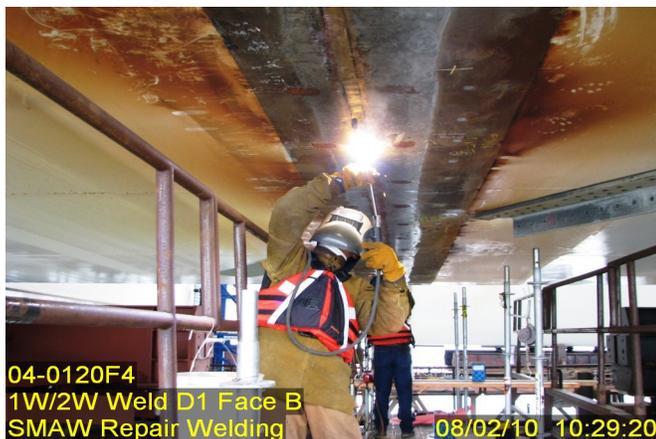
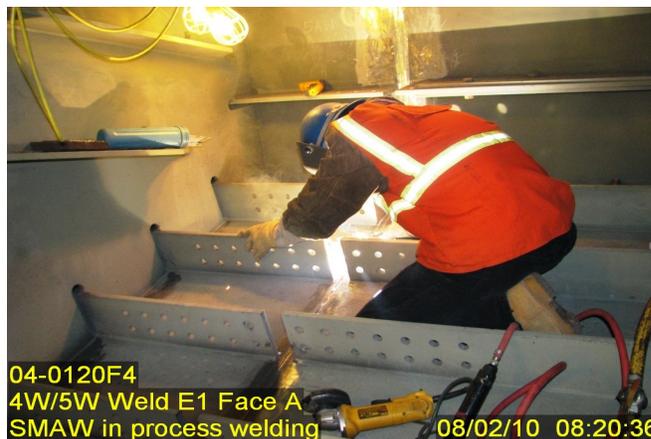
The QAI periodically observed AB/F approved welder Song Tao Huang (ID 3794) performing welding per the Shielded Metal Arc Welding (SMAW) process in the 3G (vertical) position. See photo below. The QAI observed QC Inspector John Paglieri was present to monitor the progress and verify that the welding parameters were within the limits established by the approved welding Procedure Specification (WPS) identified as ABF-WPS-D1. 5-1040A. The welding at this location was not completed during the QA Inspectors shift and the work appeared to be in general compliance with contract documents. See Summary of Conversations below.

The QAI asked of the QC Inspector which Welding Procedure Specification (WPS) was being used for the welding being performed at 4W/5W. The QC stated that it was ABF-WPS-D1.5-1040A. The QAI referenced a copy of the WPS that had been obtained from the SAS OBG QA Reference binder in the CT office trailer. The QAI noted that the WPS had FCAW-G in the Welding Process(es) section and was a revision 1. The WPS presented by the QC Inspector John Paglieri had SMAW in the Welding Process(es) section and was a revision 0. Otherwise the two WPS's appeared identical and were SMAW WPS's. The QAI later went into the QC Conex and referenced the QC Master List of WPS's and observed that the QC copy was also a Rev. 1 with the typographical error. The QAI then had a conversation with QC Leonard Cross and brought up the observed discrepancy. Mr. Cross stated that they would bring this to the attention of the AB/F QCM Mr. Jim Bowers for rectification.
