**DEPARTMENT OF TRANSPORTATION**

Contract #: 04-0120F4Cty: SF/ALA Rte: 80 PM: 13.2/13.9File #: 1.28**WELDING INSPECTION REPORT****Resident Engineer:** Pursell, Gary**Address:** 333 Burma Road**City:** Oakland, CA 94607**Report No:** WIR-016044**Date Inspected:** 02-Aug-2010**Project Name:** SAS Superstructure**OSM Arrival Time:** 1000**Prime Contractor:** American Bridge/Fluor Enterprises, a JV**OSM Departure Time:** 1830**Contractor:** American Bridge/Fluor Enterprises, a JV**Location:** Job Site

# WELDING INSPECTION REPORT

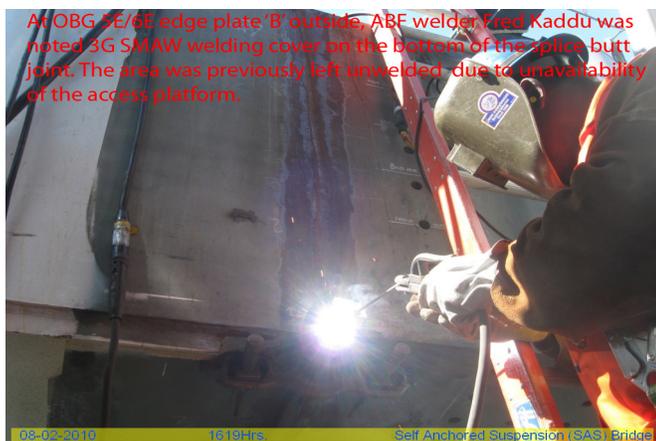
At OBG 5E/6E edge plate 'B' outside, ABF welder Fred Kaddu was noted 3G SMAW welding cover on the bottom of the splice butt joint. The area was previously left unwelded due to unavailability of the access platform.

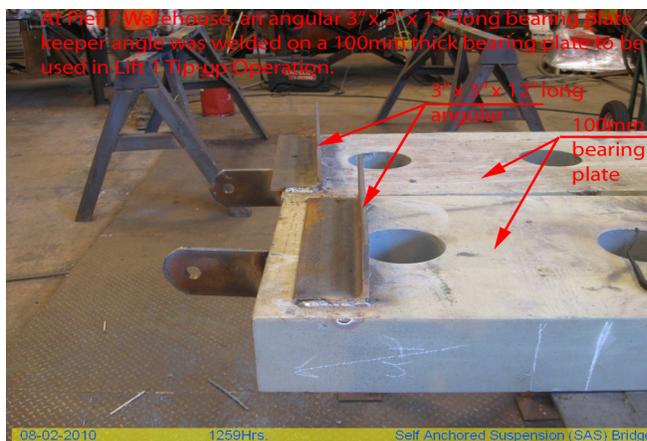
At the 17 Warehouse, an angular 3" x 1" x 1/2" long bearing plate keeper angle was welded on a 100mm thick bearing plate to be used in Lift & Tip up operation.
