Contract #: 04-0120F4Cty: SF/ALA Rte: 80 PM: 13.2/13.9File #: 1.28**WELDING INSPECTION REPORT****Resident Engineer:** Pursell, Gary**Address:** 333 Burma Road**City:** Oakland, CA 94607**Report No:** WIR-016047**Date Inspected:** 03-Aug-2010**Project Name:** SAS Superstructure**OSM Arrival Time:** 1000**Prime Contractor:** American Bridge/Fluor Enterprises, a JV**OSM Departure Time:** 1830**Contractor:** American Bridge/Fluor Enterprises, a JV**Location:** Job Site

# WELDING INSPECTION REPORT

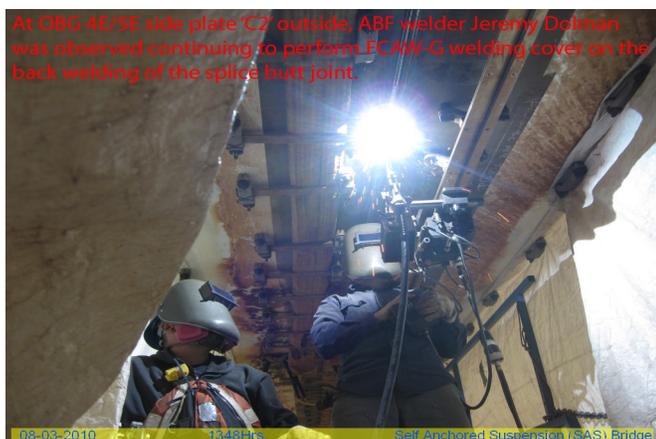
QA randomly observed ABF/JV qualified welder Jeremy Dolman continuing perform CJP groove (splice) back welding cover pass on Orthotropic Box Girder (OBG) 4E/5E side plate 'C2' outside. The welder was observed welding in the 4G (overhead) position utilizing a dual shield Flux Cored Arc Welding (FCAW-G) with E71T-1M, 1/16" diameter wire electrode and implementing Caltrans approved Welding Procedure Specification (WPS) ABF-WPS-D15-3110-4. The welder was using a track mounted welder holder assembly that was remotely controlled. The joint being welded has the backing bar gouged using the Esab Plasma Arc machine and was ground smooth. The gouged and ground splice butt joint was also Non Destructive Testing (NDT) tested using the Magnetic Particle Testing (MT). The splice joint was preheated to greater than 150 degrees Fahrenheit using Miller Proheat 35 Induction Heating System located on top of the plate prior and maintained the preheat by moving the heater blankets on the side of the plate during welding. The vicinity was also properly protected from wind and other climatic changes. During welding, ABF Quality Control (QC) Jim Cunningham was noted monitoring the welding parameters of the welder. At the end of the shift, the welder has completed the welding of the splice butt joint and was moving to the other side plate 'E' of the same OBG.

At OBG 4E/5E edge plate 'F' inside, ABF welder Hua Qiang Hwang was observed grinding the welded cover pass of the splice butt joint. The cover pass profile was not satisfactory and it has underfill on the cover. The weld joint was rejected by ABF QC due to this observation. After the completion of the grinding, the same welder was later

seen welding the cover of the same splice butt joint. The welder was observed perform manual welding in the 3G (vertical) position utilizing a dual shield Flux Cored Arc Welding (FCAW-G) with E71T-1M, 1/16" diameter wire electrode and implementing Caltrans approved Welding Procedure Specification (WPS) ABF-WPS-D15-3110-3. The splice joint was preheated to greater than 150 degrees Fahrenheit using propane gas torch prior welding. During welding, ABF Quality Control (QC) Mike Johnson was noted monitoring the welding parameters of the welder. At the end of the shift, the welder has completed the cover pass welding of the splice butt joint and was moving to the next OBG 5E/6E edge plate 'F' inside.

At OBG 5E/6E side plate 'C' outside, ABF welders Mike Maday and Bryce Howell were noted preparing their Esab plasma arc gouging machine and lining up their Bug-o track to perform gouging on the backing bar removal of the splice butt joint. At the end of the shift, the welders were still prepping their equipment and did not start gouging.
