Contract #: 04-0120F4Cty: SF/ALA Rte: 80 PM: 13.2/13.9File #: 69.28**WELDING INSPECTION REPORT****Resident Engineer:** Pursell, Gary**Address:** 333 Burma Road**City:** Oakland, CA 94607**Report No:** WIR-016127**Date Inspected:** 30-Jul-2010**Project Name:** SAS Superstructure**OSM Arrival Time:** 1900**Prime Contractor:** American Bridge/Fluor Enterprises, a JV**OSM Departure Time:** 700**Contractor:** Zhenhua Port Machinery Company, Ltd (ZPMC), Changxing Island **Location:** Shanghai, China**CWI Name:** See Below**CWI Present:** Yes No**Inspected CWI report:** Yes No N/A**Rod Oven in Use:** Yes No N/A**Electrode to specification:** Yes No N/A**Weld Procedures Followed:** Yes No N/A**Qualified Welders:** Yes No N/A**Verified Joint Fit-up:** Yes No N/A**Approved Drawings:** Yes No N/A**Approved WPS:** Yes No N/A**Delayed / Cancelled:** Yes No N/A**Bridge No:** 34-0006**Component:** OBG**Summary of Items Observed:**

OBG Segment Trial Assembly

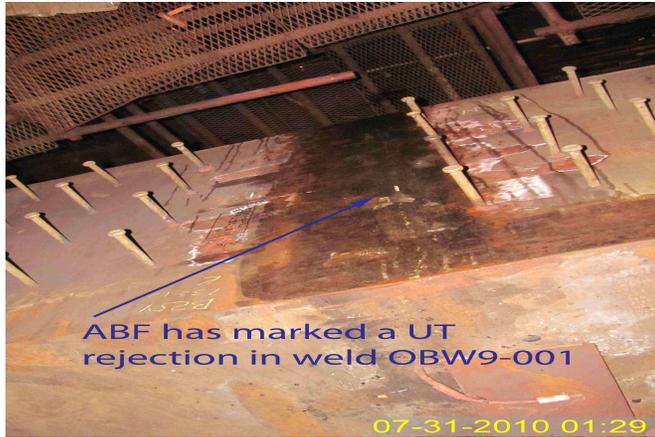
This QA Inspector observed ZPMC welder Mr. Tian Zhaoquan, stencil 045246 is using shielded metal arc welding procedure WPS-345-SMAW-4G(4F)-FCM-Repair to make repair weld OBW9-003 which joins the top deck plates between OBG Segments 9AW and 9BW. This work was being performed in accordance with weld repair document B-CWR1698. This QA Inspector measured a welding current of approximately 155 amps, the base

material was preheated with electric heating elements prior to welding and Mr. Tian Zhaoquan appeared to be certified to make this weld. This QA Inspector observed the welding electrodes are being stored in a heated portable electrode storage container. Items observed on this date appeared to generally comply with applicable contract documents.
