Contract #: 04-0120F4Cty: SF/ALA Rte: 80 PM: 13.2/13.9File #: 69.28**WELDING INSPECTION REPORT****Resident Engineer:** Pursell, Gary**Address:** 333 Burma Road**City:** Oakland, CA 94607**Report No:** WIR-016129**Date Inspected:** 01-Aug-2010**Project Name:** SAS Superstructure**OSM Arrival Time:** 1900**Prime Contractor:** American Bridge/Fluor Enterprises, a JV**OSM Departure Time:** 700**Contractor:** Zhenhua Port Machinery Company, Ltd (ZPMC), Changxing Island **Location:** Shanghai, China**CWI Name:** See Below**CWI Present:** Yes No**Inspected CWI report:** Yes No N/A**Rod Oven in Use:** Yes No N/A**Electrode to specification:** Yes No N/A**Weld Procedures Followed:** Yes No N/A**Qualified Welders:** Yes No N/A**Verified Joint Fit-up:** Yes No N/A**Approved Drawings:** Yes No N/A**Approved WPS:** Yes No N/A**Delayed / Cancelled:** Yes No N/A**Bridge No:** 34-0006**Component:** OBG**Summary of Items Observed:**

OBG Segment Trial Assembly

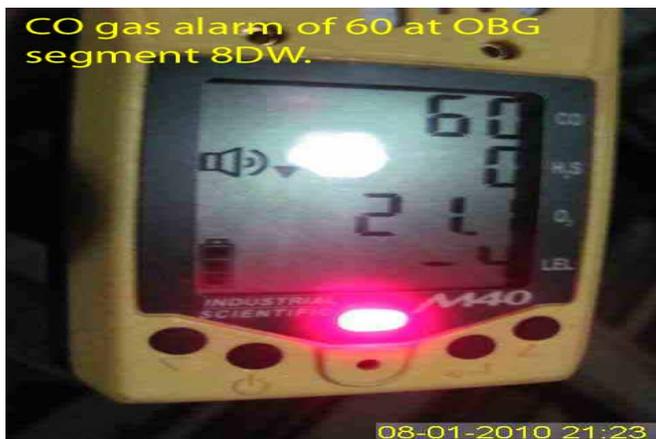
Inspector arrived in OBG segment 10AW the “Industrial Scientific Model M40” air monitor CO gas (Carbon monoxide) alarm sounded and the digital meter indicated a CO value of approximately 60. This QA Inspector informed ABF representative Mr. Kelvin Cheung of the potential health hazard due to high levels of carbon monoxide. Approximately 20 minutes later this QA Inspector entered OBG segment 10AW and observed the breathing air monitor was not alarming and it displayed an approximate CO reading of 2. See the photograph below for additional information.

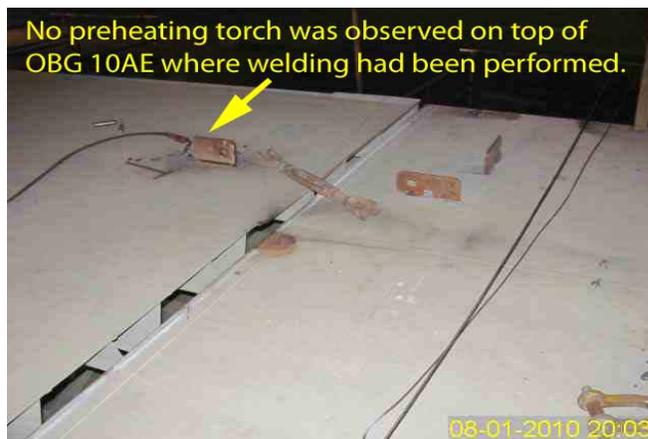
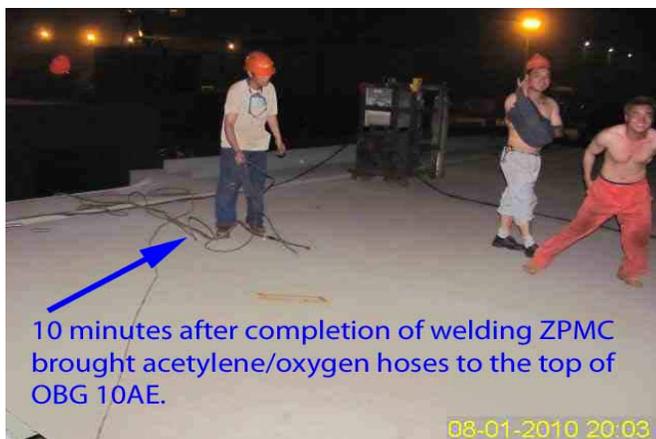
This QA Inspector observed ZPMC welder Mr. Xin Ming, stencil 053742 used flux cored welding process to perform tack welding of temporary plates to aid in the alignment of OBG deck plate weld joints between segments 9EE and 10AE. This QA Inspector observed Mr. Xin Ming appeared to be certified to make these welds. As this QA Inspector walked toward the OBG this QA Inspector observed Mr. Xin Ming performing welding of a temporary plate to the top deck. When this QA Inspector arrived the welding appears to have been completed and no acetylene/oxygen hoses or torches were observed anywhere on the OBG segments 9EE and 10AE. A few minutes later this QA Inspector observed ZPMC workers pulling an acetylene/oxygen hose to the top of OBG segment 10AE and several minutes later Mr. Xin Ming arrived, and he was carrying a torch, which he then connected to the hoses. This QA Inspector asked Mr. Xin Ming if and how he had preheated the base material for the completed weld and all the workers did not appear to speak any English. This QA Inspector later informed ZPMC CWI Mr. Liu Hua Jie that Mr. Xin Ming did not appear to have any method of preheating the area that he had welded and Mr. Liu Hua Jie informed this QA Inspector that Mr. Xin Ming had called him and he had stated that he had used a cutting torch to preheat the top deck plate prior to welding. Items observed on this date do not appear to fully comply with applicable contract documents. See the photographs below for additional information.
