DEPARTMENT OF TRANSPORTATION

Contract #: 04-0120F4Cty: SF/ALA Rte: 80 PM: 13.2/13.9File #: 1.28**WELDING INSPECTION REPORT****Resident Engineer:** Pursell, Gary**Address:** 333 Burma Road**City:** Oakland, CA 94607**Report No:** WIR-016213**Date Inspected:** 12-Aug-2010**Project Name:** SAS Superstructure**OSM Arrival Time:** 1000**Prime Contractor:** American Bridge/Fluor Enterprises, a JV**OSM Departure Time:** 1830**Contractor:** American Bridge/Fluor Enterprises, a JV**Location:** Job Site

WELDING INSPECTION REPORT

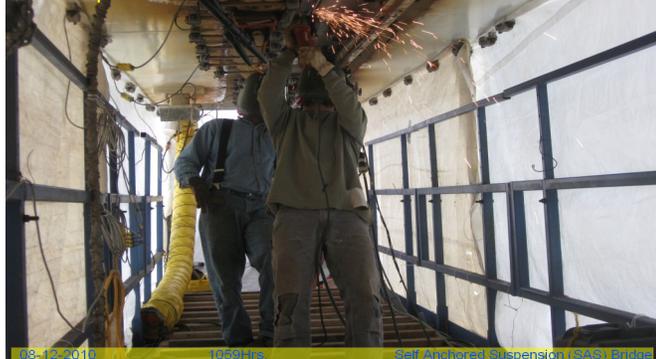
At OBG 5E/6E side plate 'C' outside, ABF welder Jeremy Dolman was noted grinding/cleaning the weld pass just welded prior to put another pass.

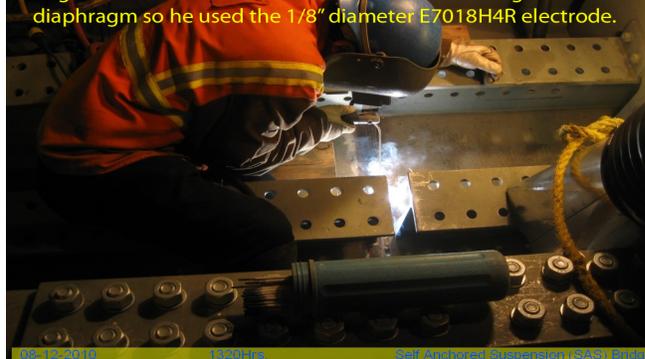
At 4W/5W side plate 'C' inside, ABF welder Songtao, Huang was observed 1G SMAW welding fill pass on the splice butt joint. The Bug-o track was not accessible to the corner of longitudinal diaphragm so he used the 1/8" diameter E7018H4R electrode.
