DEPARTMENT OF TRANSPORTATION

Quality Assurance and Source Inspection

Contract #: 04-0120F4Cty: SF/ALA Rte: 80 PM: 13.2/13.9File #: 1.28**WELDING INSPECTION REPORT****Resident Engineer:** Pursell, Gary**Address:** 333 Burma Road**City:** Oakland, CA 94607**Report No:** WIR-016248**Date Inspected:** 17-Aug-2010**Project Name:** SAS Superstructure**OSM Arrival Time:** 700**Prime Contractor:** American Bridge/Fluor Enterprises, a JV**OSM Departure Time:** 1530**Contractor:** American Bridge/Fluor Enterprises, a JV**Location:** Jobsite**CWI Name:** See below**CWI Present:** Yes No**Inspected CWI report:** Yes No N/A**Rod Oven in Use:** Yes No N/A**Electrode to specification:** Yes No N/A**Weld Procedures Followed:** Yes No N/A**Qualified Welders:** Yes No N/A**Verified Joint Fit-up:** Yes No N/A**Approved Drawings:** Yes No N/A**Approved WPS:** Yes No N/A**Delayed / Cancelled:** Yes No N/A**Bridge No:** 34-0006**Component:** SAS OBG**Summary of Items Observed:**

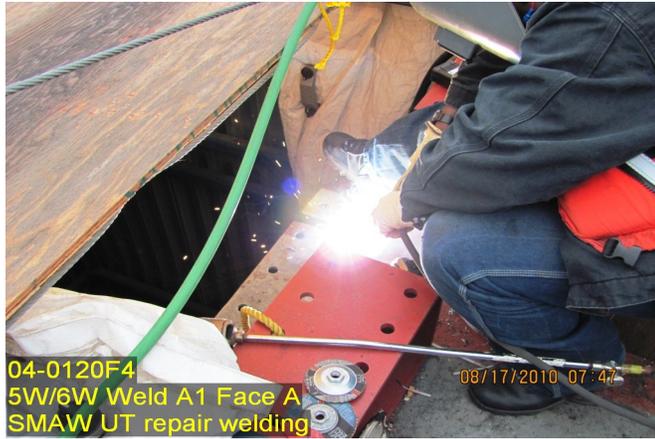
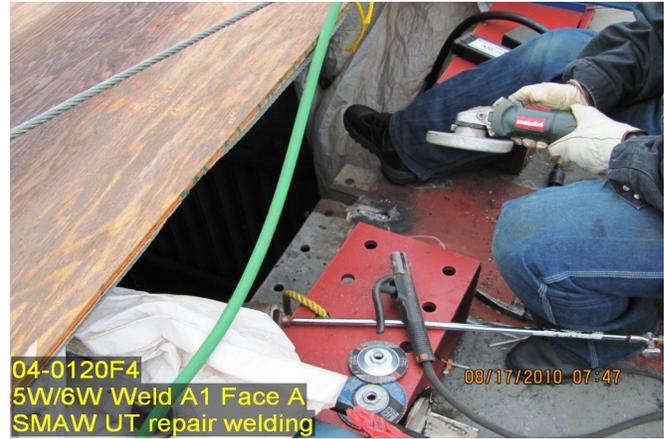
5). OBG Field Splice 5W/6W Weld ID: A1 & A5, Face A

The QAI periodically observed AB/F approved welder Kenneth Chappell (ID 3833) performing grinding at the crossbeam end of weld A5 & AB/F approved welder Fred Kaddu (ID 2188) performing welding at the counterweight side of weld A-1 per the Shielded Metal Arc Welding (SMAW) process in the 1G (flat) position. See photos below. The QAI observed QC Inspector Tony Sherwood was present to monitor the progress and verify that the welding parameters were within the limits established by the approved Welding Procedure Specification (WPS) identified as ABF-WPS-D1.5-1001-Repair. Work at this location was completed and appeared to be in general compliance with contract documents. See Summary of Conversations below.

The QAI in a conversation with the QC Inspector Tony Sherwood was informed that the QC UT of the welding at the ends of welds A1 & A5 had been inadvertently missed at the time of the welding of said locations. QC Sherwood stated that when the original QC UT repairs were welded, the ends of A1 & A5 were also welded but QC UT was only performed of the repair areas and not the new welds at the ends of welds A1 & A5. Mr. Sherwood stated that this UT was performed approximately 2 days ago and rejected areas discovered at that time are being repair welded on this date.
