Contract #: 04-0120F4Cty: SF/ALA Rte: 80 PM: 13.2/13.9File #: 82.28**WELDING INSPECTION REPORT****Resident Engineer:** Pursell, Gary**Address:** 333 Burma Road**City:** Oakland, CA 94607**Report No:** WIR-016252**Date Inspected:** 05-Aug-2010**Project Name:** SAS Superstructure**OSM Arrival Time:** 500**Prime Contractor:** American Bridge/Fluor Enterprises, a JV**OSM Departure Time:** 1330**Contractor:** Westmont Industries**Location:** Santa Fe Springs, CA.

Bridge No: 34-0006**Component:** Travelers**Summary of Items Observed:**

Traveler E2/E3-EB

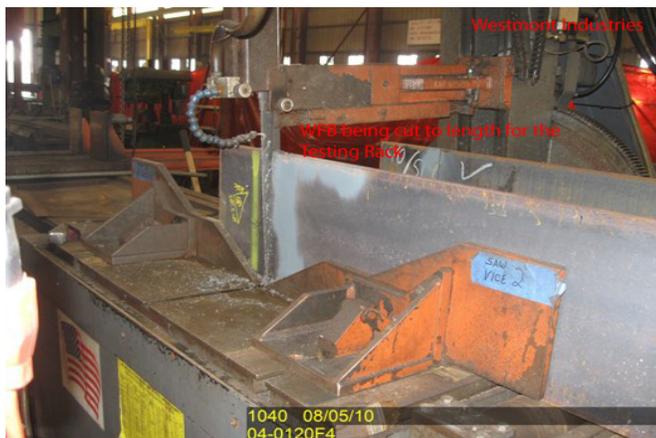
The QA Inspector observed that Mr. Harnett continued cutting TS material throughout the shift and observed that the following material was cut and identified, for the E2/E3-EB Traveler:

2 each piece mark B261- 6" x 4" x .250" x 194.4375" (152 mm x 102 mm x 6 mm x 4939 mm) Rectangular TS
3 each piece mark H263- 3" x 2" x .1875" x 47.75" (76 mm x 51 mm x 5 mm x 1213 mm) Rectangular TS
8 each piece mark K263- 3" x 2" x .1875" x 47.5625" (76 mm x 51 mm x 5 mm x 1208 mm) Rectangular TS
2 each piece mark B263- 6" x 4" x .1875" x 12.125" (152 mm x 102 mm x 5 mm x 308 mm) Rectangular TS
2 each piece mark A263- 6" x 4" x .1875" x 12.125" (152 mm x 102 mm x 5 mm x 308 mm) Rectangular TS
4 each piece mark F262- 6" x 4" x .1875" x 12.125" (152 mm x 102 mm x 5 mm x 308 mm) Rectangular TS
4 each piece mark C261- 6" x 4" x .1875" x 221" (152 mm x 102 mm x 5 mm x 5613 mm) Rectangular TS
2 each piece mark A261- 6" x 4" x .1875" x 413.8125" (152 mm x 102 mm x 5 mm x 10511 mm) Rectangular TS

The QA Inspector verified the dimensions of the above mentioned, cut to length TS material, per the shop drawings and the material appeared to be in compliance. See attached picture below.
