Quality Assurance and Source Inspection

Contract #: 04-0120F4Cty: SF/ALA Rte: 80 PM: 13.2/13.9File #: 69.28**WELDING INSPECTION REPORT****Resident Engineer:** Pursell, Gary**Address:** 333 Burma Road**City:** Oakland, CA 94607**Report No:** WIR-016285**Date Inspected:** 13-Aug-2010**Project Name:** SAS Superstructure**OSM Arrival Time:** 700**Prime Contractor:** American Bridge/Fluor Enterprises, a JV**OSM Departure Time:** 1900**Contractor:** Zhenhua Port Machinery Company, Ltd (ZPMC), Changxing Island **Location:** Shanghai, China**CWI Name:** Chen Shi Gang**CWI Present:** Yes No**Inspected CWI report:** Yes No N/A**Rod Oven in Use:** Yes No N/A**Electrode to specification:** Yes No N/A**Weld Procedures Followed:** Yes No N/A**Qualified Welders:** Yes No N/A**Verified Joint Fit-up:** Yes No N/A**Approved Drawings:** Yes No N/A**Approved WPS:** Yes No N/A**Delayed / Cancelled:** Yes No N/A**Bridge No:** 34-0006**Component:** OBG**Summary of Items Observed:**

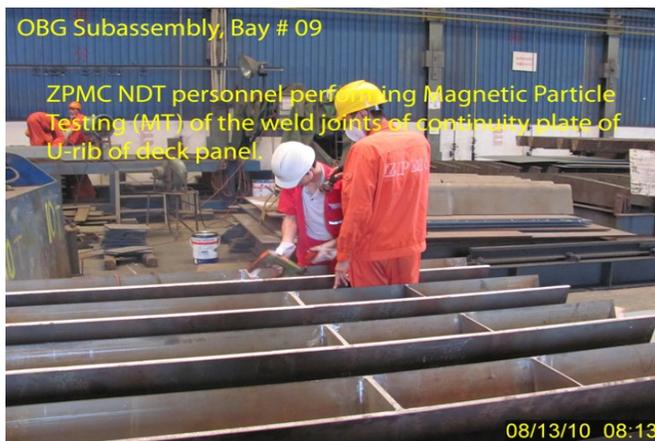
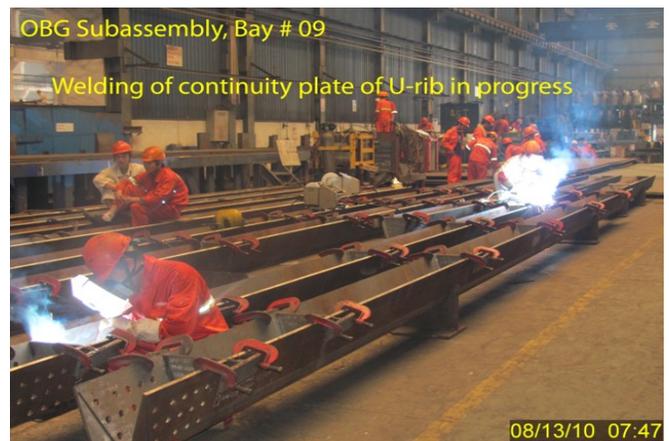
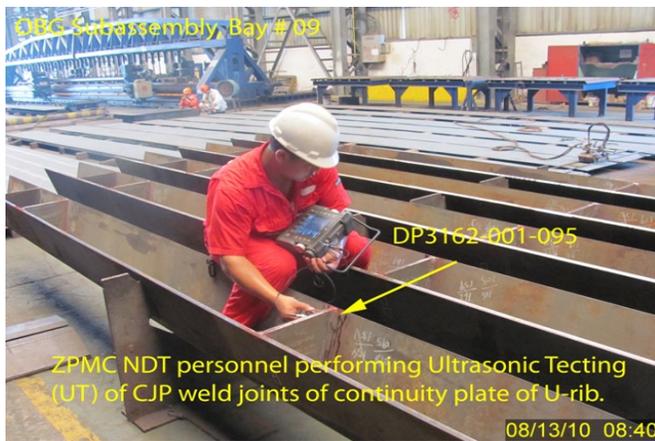
During random in process inspection this QA inspector observed that ZPMC NDT personnel Mr. Liu Zhang Min was performing Magnetic Particle Testing (MT) on the weld joints of continuity plate of U-rib of OBG deck plate. The members are identified as OBG components and the weld designations reviewed are as follows.

was performing Ultrasonic Testing (UT) on the CJP welds of continuity plate of U-rib of OBG deck plate. ZPMC NDT personnel found one non confirming indication in one of the weld joint. The members are identified as OBG components and the weld designations reviewed are as follows.

DP3162-001-044 (ZPMC NDT personnel found non confirming indication)

FCAW welding of weld joint 133 located on DP3167-001.
