Contract #: 04-0120F4Cty: SF/ALA Rte: 80 PM: 13.2/13.9File #: 82.28**WELDING INSPECTION REPORT****Resident Engineer:** Pursell, Gary**Address:** 333 Burma Road**City:** Oakland, CA 94607**Report No:** WIR-016406**Date Inspected:** 04-Aug-2010**Project Name:** SAS Superstructure**OSM Arrival Time:** 500**Prime Contractor:** American Bridge/Fluor Enterprises, a JV**OSM Departure Time:** 1330**Contractor:** Westmont Industries**Location:** Santa Fe Springs, CA.

Bridge No: 34-0006**Component:** Travelers**Summary of Items Observed:**

WELDING INSPECTION REPORT

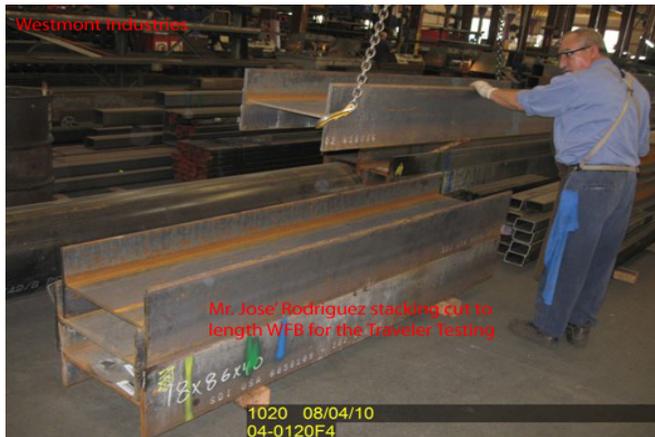
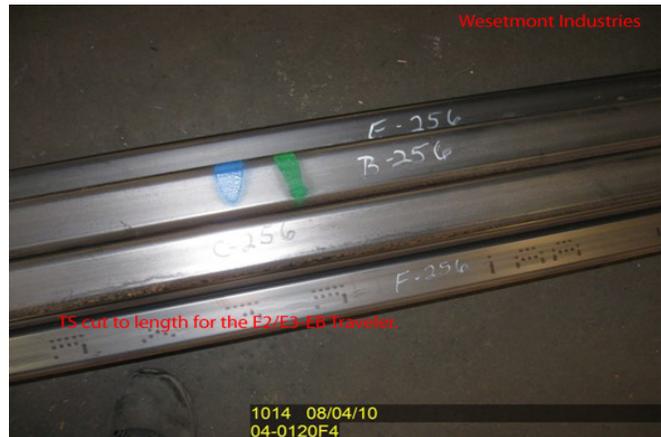
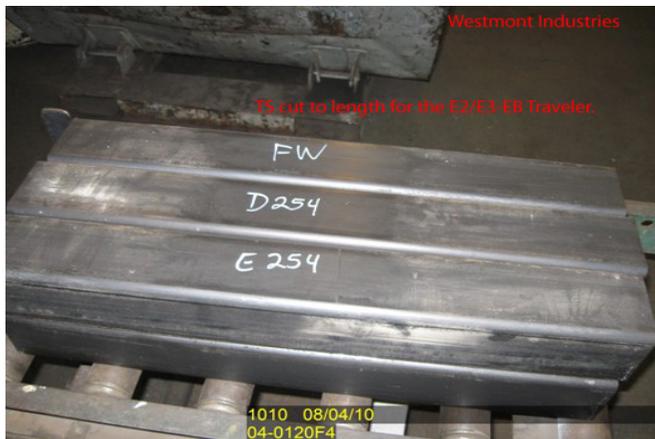
The QA Inspector observed that Mr. Hartnett was utilizing a Marvel Brand 15 A series horizontal band saw, to perform the cutting operations at production station # 1 and observed that the material being cut, is identified as 3 1/2" x 2 1/2" x .1875" rectangular tube steel.

The QA Inspector verified the dimensions of the cut to length TS, per the shop drawings and the TS appeared to be in compliance.

The QA Inspector observed that the material being cut is identified as Wide Flange Beam (WFB) and that Mr. Rodriguez was performing a square cut on the end of the WFB. Mr. Rodriguez explained to the QA Inspector that he was provided a list of material to be cut to a specific length, by the WMI shop supervisor, Mr. George Grayum, per the shop drawings. Mr. Rodriguez further explained that he was cutting the material to these specific lengths and marking the material with a white paint stick marker, to identify the individual cut pieces of material, per the shop drawing bill of material list.

The QA Inspector verified the dimensions of the cut to length WFB material, per the shop drawings and the WFB appeared to be in compliance.

The QA Inspector observed that the above mentioned TS and WFB material, had been previously inspected, with the MTR's provided and the QA Inspector had previously informed WMI that the material was OK to Cut. See attached pictures below.

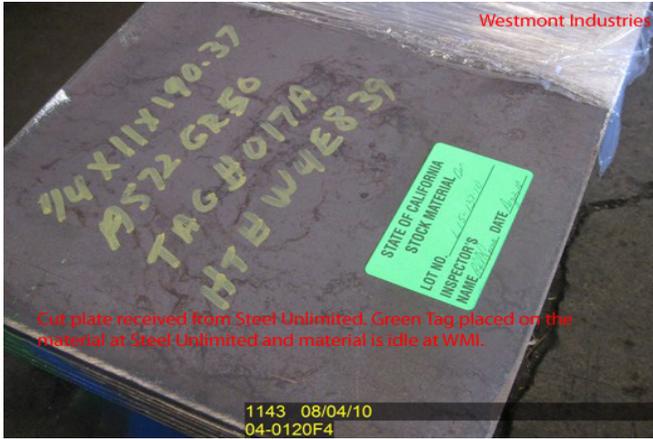
Mr. Rodriguez explained that Steel Unlimited had completed a TL38 Caltrans Inspection Request form, for an inspection on the material, prior to releasing to WMI and the QA Inspector observed the material was strategically stacked in a banded pile, idle in WMI fabrication Bay # 4. The QA Inspector observed that the material had been cut at Steel Unlimited, in Rialto CA.

On this date, the QA Inspector observed that the plate material had been previously released by METS, has a green tag dated 8/2/10 and an assigned Lot # L15-137-10.

27 each-A572 Gr. 50 .250" x 11" x 190.37" plate-Heat # W4E849.

See attached picture below.
