Contract #: 04-0120F4Cty: SF/ALA Rte: 80 PM: 13.2/13.9File #: 82.28**WELDING INSPECTION REPORT****Resident Engineer:** Pursell, Gary**Address:** 333 Burma Road**City:** Oakland, CA 94607**Report No:** WIR-016409**Date Inspected:** 12-Aug-2010**Project Name:** SAS Superstructure**OSM Arrival Time:** 500**Prime Contractor:** American Bridge/Fluor Enterprises, a JV**OSM Departure Time:** 1330**Contractor:** Westmont Industries**Location:** Santa Fe Springs, CA.

**Bridge No:** 34-0006**Component:** Travelers**Summary of Items Observed:**

**Traveler E2/E3-EB**

### Assembly A214

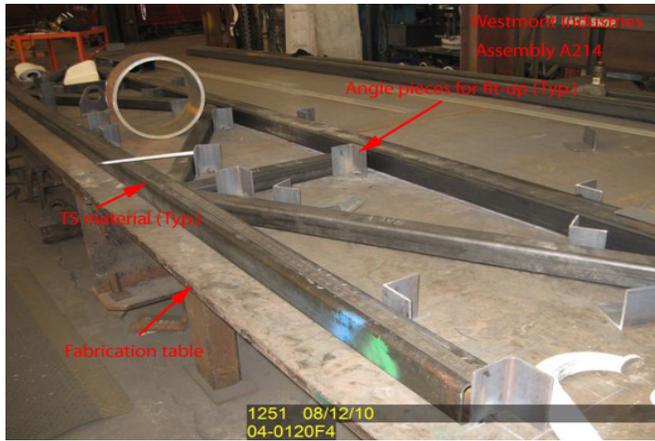
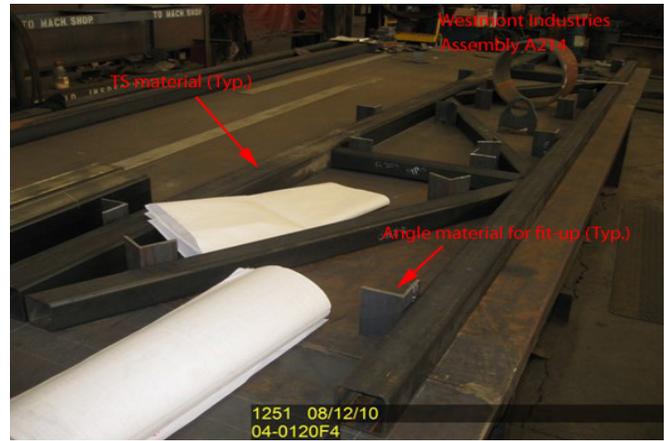
On this date, the QA Inspector observed production personnel, Mr. Juan Mora, piecing or fitting together rectangular TS for E2/E3-EB Traveler Assembly A214.

The QA Inspector observed Mr. Mora placing the TS material on a flat steel fabrication table and arranging the material, according to the piece marks which were previously marked on the TS. The QA Inspector observed that the material is marked and is listed as follows:

The QA Inspector observed that once the material was arranged per the individual piece marks, that Mr. Mora then placed pieces of previously cut 3" x 3" x 3" (76 mm x 76 mm x 76 mm) angle material, on the flat steel fabrication table.

The QA Inspector later observed that a total of 20 pieces of angle had been placed in strategically located positions around the TS material, to fit and hold the material in place. Once the angle material was placed, the QA Inspector observed that Mr. Mora then tack welding the angle material pieces to the flat steel fabrication table. The QA Inspector observed Mr. Mora performing this task, throughout the shift and Mr. Mora explained that each individual weld joint for this assembly, will eventually be tacked at a later date.

The QA Inspector observed that the fitting of the TS material for assembly A214, appeared to be in compliance with the approved shop drawings.
