Quality Assurance and Source Inspection

Contract #: 04-0120F4Cty: SF/ALA Rte: 80 PM: 13.2/13.9File #: 69.28**WELDING INSPECTION REPORT****Resident Engineer:** Pursell, Gary**Address:** 333 Burma Road**City:** Oakland, CA 94607**Report No:** WIR-016435**Date Inspected:** 24-Aug-2010**Project Name:** SAS Superstructure**OSM Arrival Time:** 700**Prime Contractor:** American Bridge/Fluor Enterprises, a JV**OSM Departure Time:** 1900**Contractor:** Zhenhua Port Machinery Company, Ltd (ZPMC), Changxing Island **Location:** Shanghai, China**CWI Name:** Wu shi guo/Xu Tao**CWI Present:** Yes No**Inspected CWI report:** Yes No N/A**Rod Oven in Use:** Yes No N/A**Electrode to specification:** Yes No N/A**Weld Procedures Followed:** Yes No N/A**Qualified Welders:** Yes No N/A**Verified Joint Fit-up:** Yes No N/A**Approved Drawings:** Yes No N/A**Approved WPS:** Yes No N/A**Delayed / Cancelled:** Yes No N/A**Bridge No:** 34-0006**Component:** OBG**Summary of Items Observed:**

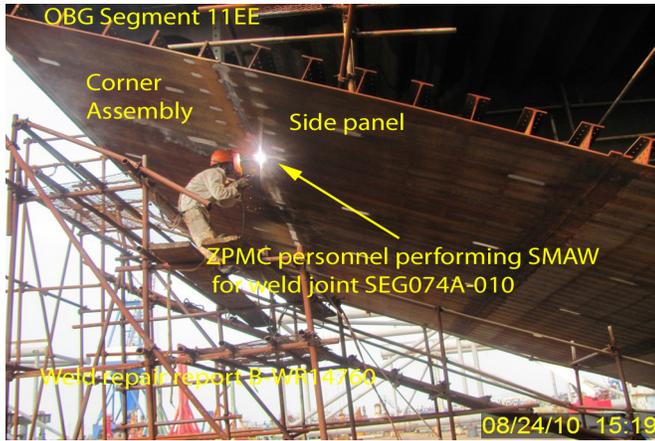
SMAW welding of weld joint no: SEG074A-010 located on Side panel to Corner Assembly of OBG Segment 11EE. Welder is identified as #043661. ZPMC CWI is identified as Mr. Wu shi guo. Welding was performed according to the weld repair report B-WR14760 and UT report number: B787-UT-14725. The welding variables

recorded by QC appeared to comply with the WPS-345-SMAW-4G(4F)-Repair. Please see the attached picture.

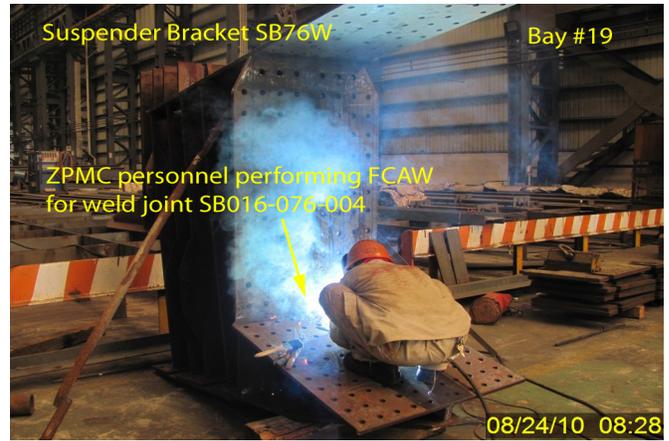
FCAW welding of weld joint no: SB016-076-004 located on OBG Segment Suspender Bracket SB76W. Welder is identified as #062794. ZPMC CWI is identified as Mr. Xu Tao. Welding was performed with the temporary weld repair report. The welding variables recorded by QC appeared to comply with the WPS-345-FCAW-2G(2F)-Repair. Please see the attached picture.
