DEPARTMENT OF TRANSPORTATION

Contract #: 04-0120F4Cty: SF/ALA Rte: 80 PM: 13.2/13.9File #: 1.28**WELDING INSPECTION REPORT****Resident Engineer:** Pursell, Gary**Address:** 333 Burma Road**City:** Oakland, CA 94607**Report No:** WIR-016440**Date Inspected:** 24-Aug-2010**Project Name:** SAS Superstructure**OSM Arrival Time:** 1000**Prime Contractor:** American Bridge/Fluor Enterprises, a JV**OSM Departure Time:** 1830**Contractor:** American Bridge/Fluor Enterprises, a JV**Location:** Job Site**CWI Name:** See Below**CWI Present:** Yes No**Inspected CWI report:** Yes No N/A**Rod Oven in Use:** Yes No N/A**Electrode to specification:** Yes No N/A**Weld Procedures Followed:** Yes No N/A**Qualified Welders:** Yes No N/A**Verified Joint Fit-up:** Yes No N/A**Approved Drawings:** Yes No N/A**Approved WPS:** Yes No N/A**Delayed / Cancelled:** Yes No N/A**Bridge No:** 34-0006**Component:** Orthotropic Box Girders**Summary of Items Observed:**

WELDING INSPECTION REPORT

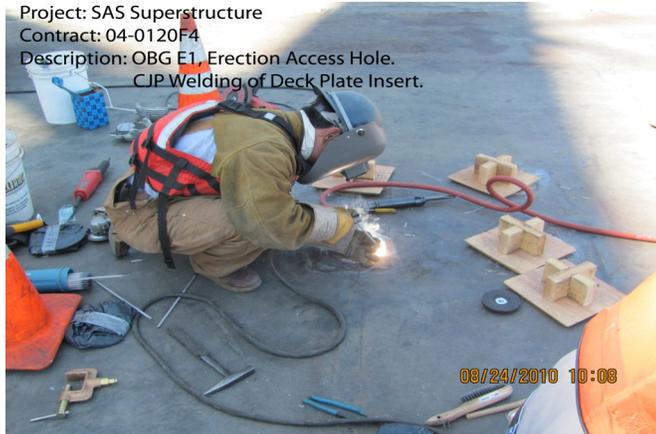
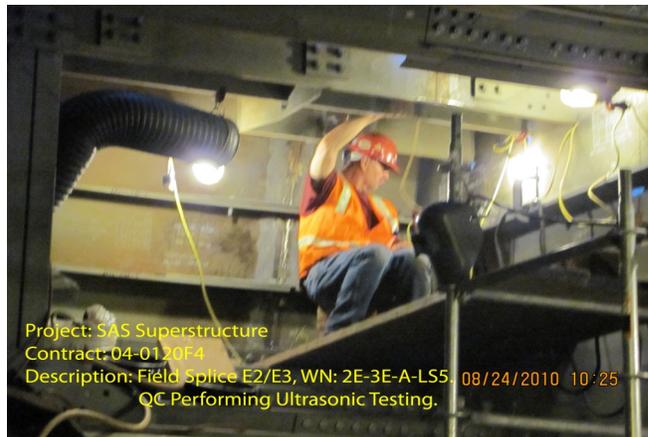
The QAI observed the Shielded Metal Arc Welding (SMAW) of the erection access hole identified as Weld Number (WN): 1AE8 located on the deck plate. The Complete Joint Penetration (CJP) groove welding was performed by welding personnel James Zhen ID-6001 utilizing the Welding Procedure Specification (WPS) ABF-WPS-D15-1050A, Rev. 1 and utilizing the 4.0mm Lincoln electrode. The WPS was also used by the AB/F Quality Control (QC) Inspector Mike Johnson as a reference to monitor the welding and verify the Direct Current Electrode Positive (DCEP) welding parameters which was recorded as 137 amps by the QC inspector. The groove joint appeared to comply with the AWS joint designation identified as B-U4a. The minimum preheat temperature of 20 degrees Celsius and the maximum interpass temperature of 230 degrees Celsius were verified.

Project: SAS Superstructure
Contract: 04-0120F4
Description: OBG E1, Erection Access Hole.
CJP Welding of Deck Plate Insert.
