DEPARTMENT OF TRANSPORTATION

Quality Assurance and Source Inspection

Contract #: 04-0120F4Cty: SF/ALA Rte: 80 PM: 13.2/13.9File #: 69.28**WELDING INSPECTION REPORT****Resident Engineer:** Pursell, Gary**Address:** 333 Burma Road**City:** Oakland, CA 94607**Report No:** WIR-016475**Date Inspected:** 26-Aug-2010**Project Name:** SAS Superstructure**OSM Arrival Time:** 700**Prime Contractor:** American Bridge/Fluor Enterprises, a JV**OSM Departure Time:** 1900**Contractor:** Zhenhua Port Machinery Company, Ltd (ZPMC), Changxing Island **Location:** Shanghai, China

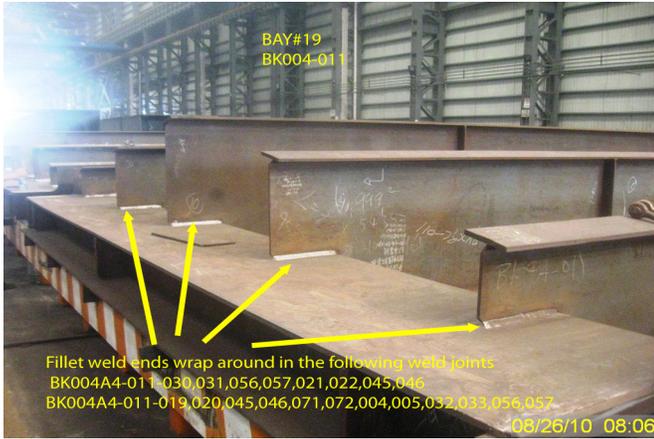
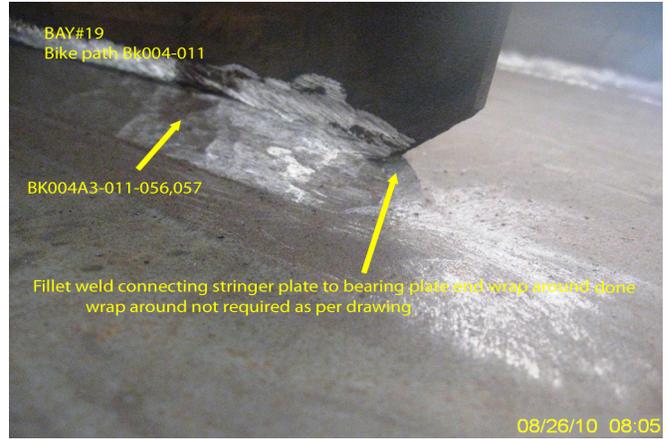
During random in-process observations of the fabrication of OBG Bike path BK004-011, this Caltrans Quality Assurance (QA) Inspector discovered the following issue:

-ZPMC personnel have performed wrap around welds of the Stringer to Bearing plate fillet weld joints.

- The welds are identified as

BK004A3-011-030,031,056,057,021,022,045,046.

BK004A4-011-019,020,045,046,071,072,004,005,032,033,056,057.

For more information please see the Incident report

04-0120F4_TL-15_B247_08-26-10_BK004-011__Wrap_around_Fillet_weld_Ends
