Contract #: 04-0120F4Cty: SF/ALA Rte: 80 PM: 13.2/13.9File #: 82.28**WELDING INSPECTION REPORT****Resident Engineer:** Pursell, Gary**Address:** 333 Burma Road**City:** Oakland, CA 94607**Report No:** WIR-016551**Date Inspected:** 19-Aug-2010**Project Name:** SAS Superstructure**OSM Arrival Time:** 500**Prime Contractor:** American Bridge/Fluor Enterprises, a JV**OSM Departure Time:** 1330**Contractor:** Westmont Industries**Location:** Santa Fe Springs, CA.

Bridge No: 34-0006**Component:** Travelers**Summary of Items Observed:**

Traveler E2/E3-EB

Traveler Test Rack

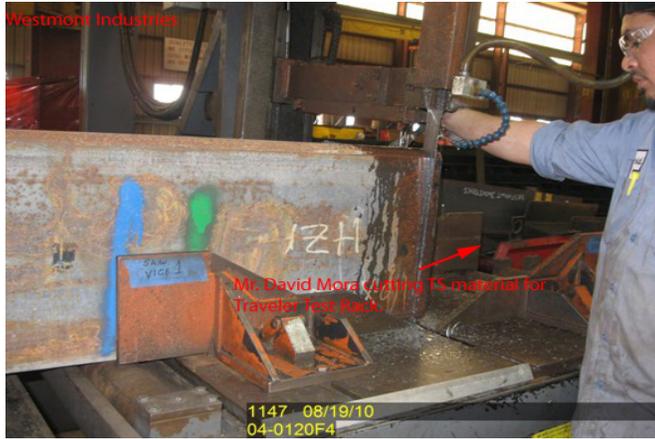
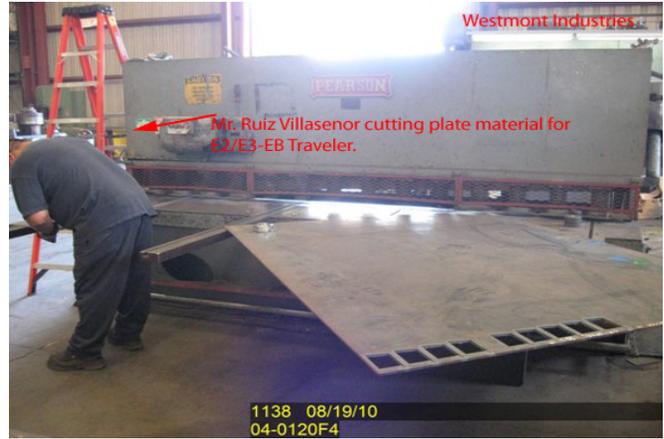
The QA Inspector then observed WMI production personnel, Mr. Ruiz Villasenor, utilizing the Pearson shear to cut plate material. Mr. Villasenor explained that he was currently cutting .250" (6 mm) material, to be utilized for the fabrication of the E2/E3-EB Traveler.

Mr. Villasenor explained that each sheet of plate material is placed in the shear for cutting, utilizing the overhead

shop bay crane and that 3/8" (10 mm) thick plate material will be placed in the shear, later in the shift and cutting will continue on the material for the E2/E3-EB Traveler (WMI Job # 11200).

The QA Inspector observed that the shearing or cutting of the plate material, continued throughout the shift and observed that by the end of shift, the following material was cut and identified on each piece, by Mr. Villasenor:

On this date, the QA Inspector observed WMI production personnel, Mr. David Mora, cutting material for the Traveler Test Track, at production station identified as # 3.

The QA Inspector observed Mr. Mora utilizing a Hem Saw brand VT 130A-60 adjustable angle band saw to perform this task and observed that the material being cut was identified as 16" (406 mm) x 16" (406 mm) x .50" (13mm) square Tube Steel (TS) material. Mr. Mora explained that he was instructed by Shop Superintendent George Grayum to cut the material to length, per the shop drawings (Reference drawing # WMI -TTR-7-piece mark b).

The QA Inspector observed that the above mentioned material had been previously inspected by the QA Inspector and appeared to be in compliance with the contract requirements.
