**DEPARTMENT OF TRANSPORTATION**

Quality Assurance and Source Inspection

Contract #: 04-0120F4Cty: SF/ALA Rte: 80 PM: 13.2/13.9File #: 69.28**WELDING INSPECTION REPORT****Resident Engineer:** Siegenthaler, Peter**Address:** 333 Burma Road**City:** Oakland, CA 94607**Report No:** WIR-016587**Date Inspected:** 06-Sep-2010**Project Name:** SAS Superstructure**OSM Arrival Time:** 700**Prime Contractor:** American Bridge/Fluor Enterprises, a JV**OSM Departure Time:** 1900**Contractor:** Zhenhua Port Machinery Company, Ltd (ZPMC), Changxing Island **Location:** Shanghai, China**CWI Name:** Zhu Zhong Hai.**CWI Present:** Yes No**Inspected CWI report:** Yes No N/A**Rod Oven in Use:** Yes No N/A**Electrode to specification:** Yes No N/A**Weld Procedures Followed:** Yes No N/A**Qualified Welders:** Yes No N/A**Verified Joint Fit-up:** Yes No N/A**Approved Drawings:** Yes No N/A**Approved WPS:** Yes No N/A**Delayed / Cancelled:** Yes No N/A**Bridge No:** 34-0006**Component:** OBG components.**Summary of Items Observed:**

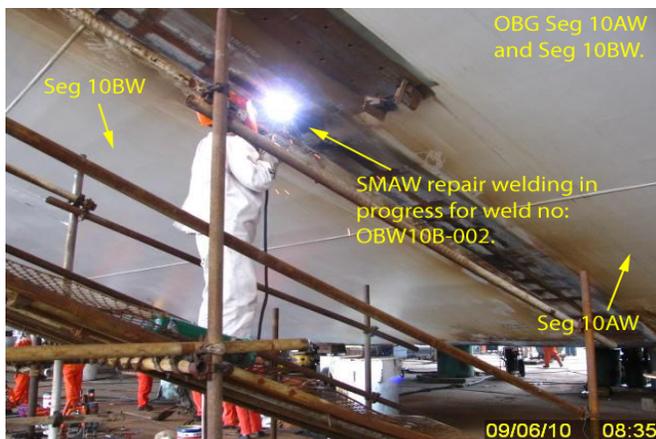
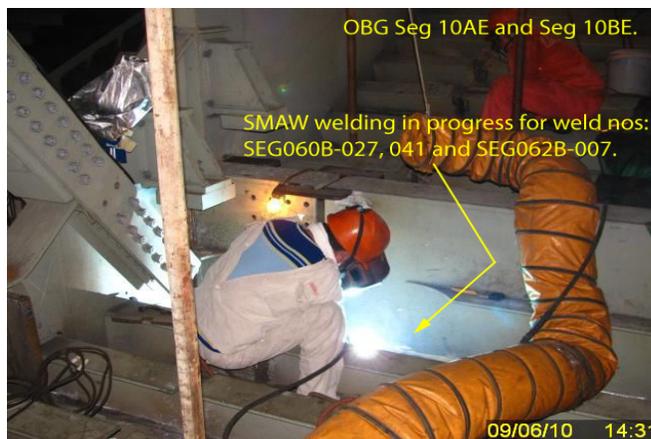
Repair welding on weld joint no: OBW10B-002. Welding process was identified as SMAW. The welder was identified as 067656 and was observed welding in the 4G position. ZPMC QC was identified as Wang Zhu. The welding variables recorded by QC appeared to comply with WPS: 345-SMAW-4G(4F)-FCM-Repair-1. Repair welding was done as per Welding Repair Report (WRR): B-WR-14920 Rev-0. See attached photo for further details.

The FCAW process on weld joint no: SEG060B-027. The welder is identified as 040367 and was observed welding in the 2F position. ZPMC QC was identified as Liu Hua Jie. The welding variables recorded by QC appeared to comply with WPS: B-T-2132. See attached photo for further details.

The FCAW process on weld joint no: SEG060B-041. The welder is identified as 040367 and was observed welding in the 2G position. ZPMC QC was identified as Liu Hua Jie. The welding variables recorded by QC appeared to comply with WPS: B-T-2232-TC-U4b-F. See attached photo for further details.

The FCAW process on weld joint no: SEG062B-007. The welder is identified as 040367 and was observed welding in the 2F position. ZPMC QC was identified as Liu Hua Jie. The welding variables recorded by QC appeared to comply with WPS: B-T-2132. See attached photo for further details.
