DEPARTMENT OF TRANSPORTATION

Quality Assurance and Source Inspection

Contract #: 04-0120F4Cty: SF/ALA Rte: 80 PM: 13.2/13.9File #: 1.28**WELDING INSPECTION REPORT****Resident Engineer:** Siegenthaler, Peter**Address:** 333 Burma Road**City:** Oakland, CA 94607**Report No:** WIR-016650**Date Inspected:** 08-Sep-2010**Project Name:** SAS Superstructure**OSM Arrival Time:** 1000**Prime Contractor:** American Bridge/Fluor Enterprises, a JV**OSM Departure Time:** 1830**Contractor:** American Bridge/Fluor Enterprises, a JV**Location:** Job Site

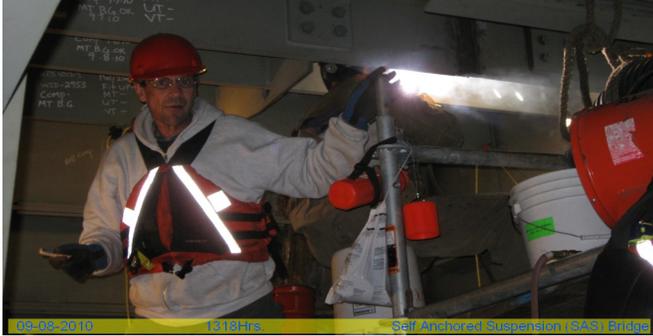
At OBG 1W/2W longitudinal stiffeners LS1, LS2 and LS3 inside, ABF welder Wai Kitlai was observed back welding the stiffener splice joint LS2 using SMAW with 1/8" diameter E9018H4R electrode. ABF QC Tom Pasqualone was also noted monitoring the welder

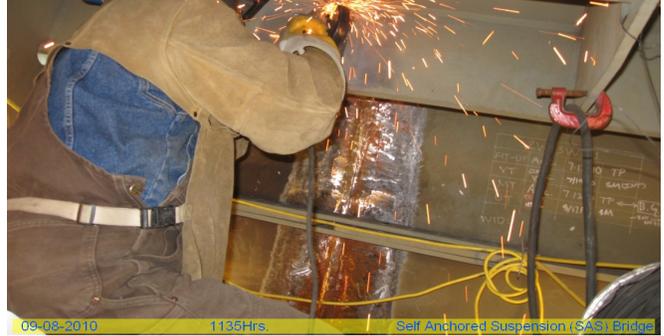
At OBG 2W/3W longitudinal stiffener LS4, LS5 and LS6 inside, ABF welder Yao Xin Liang was observed grinding/cleaning the joint surface of LS6 prior to perform buttering on the 15mm root gap of the splice butt joint.
