**DEPARTMENT OF TRANSPORTATION**

Contract #: 04-0120F4Cty: SF/ALA Rte: 80 PM: 13.2/13.9File #: 69.28**WELDING INSPECTION REPORT****Resident Engineer:** Siegenthaler, Peter**Address:** 333 Burma Road**City:** Oakland, CA 94607**Report No:** WIR-016657**Date Inspected:** 08-Sep-2010**Project Name:** SAS Superstructure**OSM Arrival Time:** 1900**Prime Contractor:** American Bridge/Fluor Enterprises, a JV**OSM Departure Time:** 700**Contractor:** Zhenhua Port Machinery Company, Ltd (ZPMC), Changxing Island **Location:** Shanghai, China**CWI Name:** See Below**CWI Present:** Yes No**Inspected CWI report:** Yes No N/A**Rod Oven in Use:** Yes No N/A**Electrode to specification:** Yes No N/A**Weld Procedures Followed:** Yes No N/A**Qualified Welders:** Yes No N/A**Verified Joint Fit-up:** Yes No N/A**Approved Drawings:** Yes No N/A**Approved WPS:** Yes No N/A**Delayed / Cancelled:** Yes No N/A**Bridge No:** 34-0006**Component:** OBG**Summary of Items Observed:**

**OBG Segment Trial Assembly**

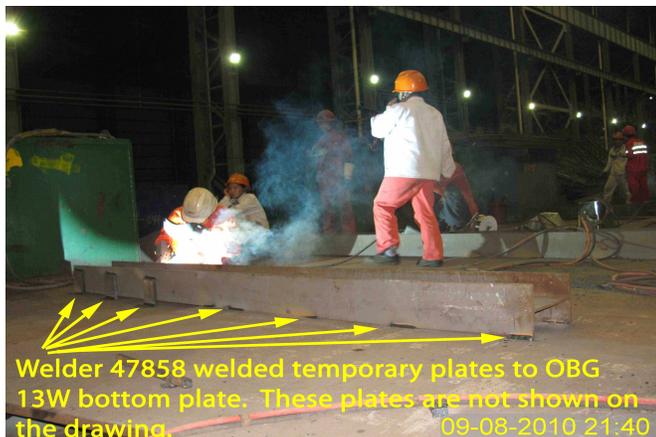
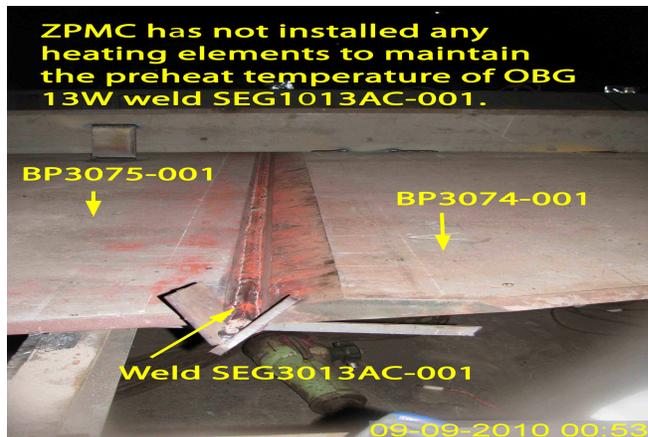
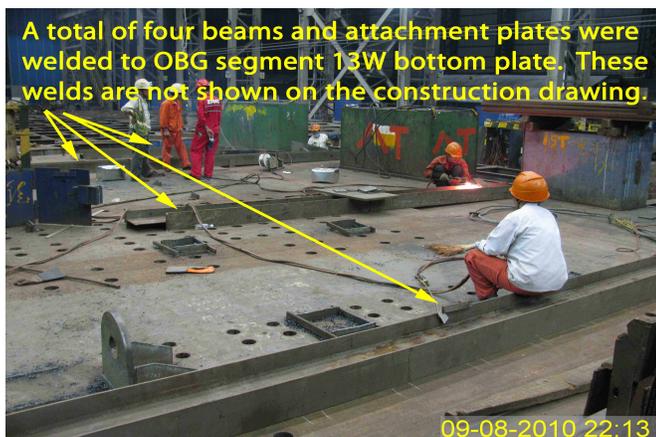
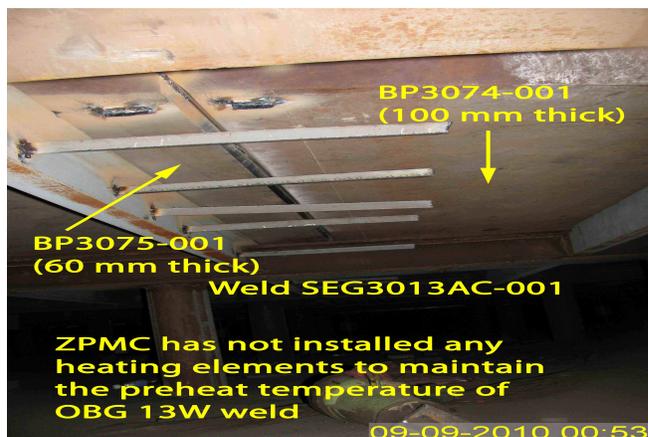
This QA Inspector observed ZPMC appears to have completed welding approximately 25% of OBG segment 13AW baseplate groove butt weld SEG3013AC-001 and welders 45268, 47864, 51348 and 45196 were using the shielded metal arc welding process to install temporary lifting attachment plates to the edge of the 60 mm thick OBG segment 13AW baseplate BP3075. Welder Mr. He Hande, stencil 47858 performed welding of temporary beams and other plates to the top of OBG segment 13AW baseplates BP3075 and BP3076. Note: portions of these plates are classified as (SPCM) Seismic Performance Critical Materials. These temporary plates are not shown on the construction drawings and have not been approved by Engineering. Caltrans TC-RFI-0075R0 dated 24-Jun-2010 states lift 13A bottom plate transverse welds should not be allowed to cool to ambient temperature until all welding is complete. Following completion of this welding, all ZPMC workers left the area and the overhead lights in Bay 14 were turned off. This QA Inspector observed ZPMC has not installed any heating

elements on OBG lift 13AW. This QA Inspector informed ABF representative Mr. Kelvin Chueng and phoned ZPMC CWI Mr. Geng Wei that this QA Inspector will be issuing an incident report to document ZPMC installing temporary beams to OBG segment 13AW without prior approval and ZPMC's failure to maintain the preheat as required by Caltrans TC-RFI-0075R0 dated 24-Jun-2010.
