Contract #: 04-0120F4Cty: SF/ALA Rte: 80 PM: 13.2/13.9File #: 1.28**WELDING INSPECTION REPORT****Resident Engineer:** Siegenthaler, Peter**Address:** 333 Burma Road**City:** Oakland, CA 94607**Report No:** WIR-016746**Date Inspected:** 13-Sep-2010**Project Name:** SAS Superstructure**OSM Arrival Time:** 700**Prime Contractor:** American Bridge/Fluor Enterprises, a JV**OSM Departure Time:** 1530**Contractor:** American Bridge/Fluor Enterprises, a JV**Location:** Jobsite**CWI Name:** See below**CWI Present:** Yes No**Inspected CWI report:** Yes No N/A**Rod Oven in Use:** Yes No N/A**Electrode to specification:** Yes No N/A**Weld Procedures Followed:** Yes No N/A**Qualified Welders:** Yes No N/A**Verified Joint Fit-up:** Yes No N/A**Approved Drawings:** Yes No N/A**Approved WPS:** Yes No N/A**Delayed / Cancelled:** Yes No N/A**Bridge No:** 34-0006**Component:** SAS OBG**Summary of Items Observed:**

- 1). OBG Field Welding of Lower Lug and Drip Edge Restoration between PP12 - PP13
- 2). OBG Field Splice 4W/5W Welds D1 & D2, Face B (FCAW-G)
- 3). OBG Field Splice 3E/4E Weld ALS5 Face A and B (QAI Verification)
- 4). OBG Field Splice 6E/7E Welds D1 & D2, Face A (SMAW)

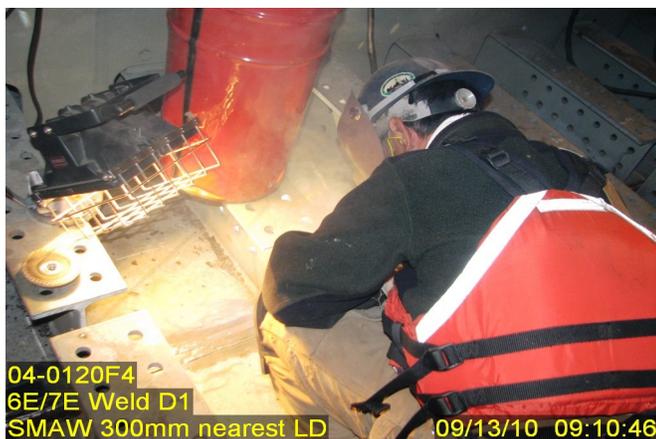
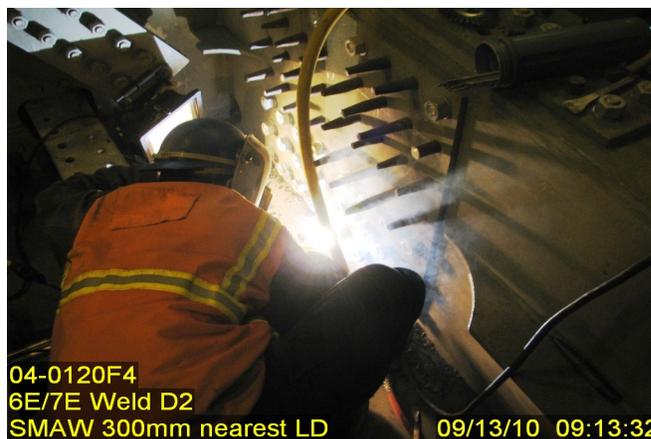
4). OBG Field Splice 6E/7E Welds D1 & D2, Face A (SMAW)

The QAI periodically observed AB/F approved welders Song Tao Huang (ID 3794) and James Zhen (ID 6001) performing welding per the SMAW process to complete the outer 300mm of welds D1 and D2. Welder 3794 was welding on D2 and welder 6001 was welding on D1. See photos below. QC Inspector John Pagliero was periodically present to monitor the progress and verify that the welding parameters were within the limits established by the approved welding Procedure Specification (WPS) identified as ABF-WPS-D1.5-1040C. Welding was complete at these locations on this date. The QAI observed that the work appeared to be in general compliance with contract documents.
