Contract #: 04-0120F4Cty: SF/ALA Rte: 80 PM: 13.2/13.9File #: 82.28**WELDING INSPECTION REPORT****Resident Engineer:** Siegenthaler, Peter**Address:** 333 Burma Road**City:** Oakland, CA 94607**Report No:** WIR-016768**Date Inspected:** 01-Sep-2010**Project Name:** SAS Superstructure**OSM Arrival Time:** 500**Prime Contractor:** American Bridge/Fluor Enterprises, a JV**OSM Departure Time:** 1330**Contractor:** Westmont Industries**Location:** Santa Fe Springs, CA.**CWI Name:** R. Rodriguez, R. Dominguez**CWI Present:** Yes No**Inspected CWI report:** Yes No N/A**Rod Oven in Use:** Yes No N/A**Electrode to specification:** Yes No N/A**Weld Procedures Followed:** Yes No N/A**Qualified Welders:** Yes No N/A**Verified Joint Fit-up:** Yes No N/A**Approved Drawings:** Yes No N/A**Approved WPS:** Yes No N/A**Delayed / Cancelled:** Yes No N/A**Bridge No:** 34-0006**Component:** Travelers**Summary of Items Observed:**

Traveler E2/E3-EB

WELDING INSPECTION REPORT

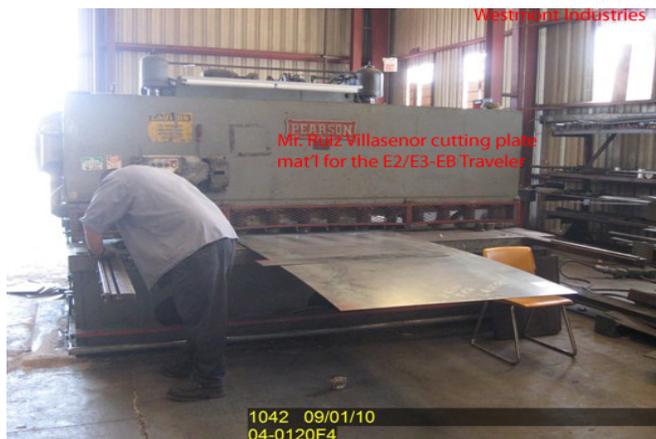
The QA Inspector observed that the shearing or cutting of the plate material, continued throughout the shift and observed that by the end of shift, the following material was cut and identified on each piece, by Mr. Villasenor:

The QA Inspector also observed that the plate material had been previously inspected with the MTR's provided and the QA Inspector had previously written "OK to Cut" on the material.

See attached picture below.

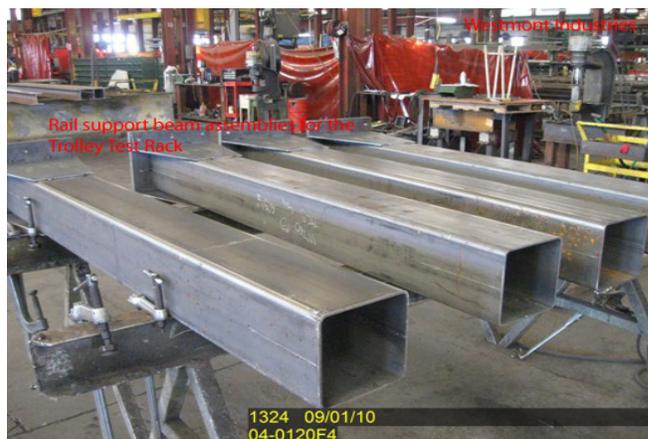
On this date, the QA Inspector observed Westmont Industries (WMI), production welder Larry Swanson, (WID # 3048), performing tack welding, for the fabrication of the Trolley Test Rack. The QA Inspector observed Mr. Swanson utilizing the Flux Core Arc Welding (FCAW) process and that Mr. Swanson was currently qualified to perform the FCAW tacking. The QA Inspector observed that Mr. Swanson was utilizing a Miller brand machine and wire feeder, to perform the tack welding and that Ultracore 71A85 (.045") diameter wire was being utilized.

The QA Inspector observed that the tack welding was being performed on the Rail Support Beam Assemblies (Reference Drawing # TTC-5) and the tack welding appeared to be in compliance with the applicable WPS.

See attached picture below.
