DEPARTMENT OF TRANSPORTATION

Contract #: 04-0120F4Cty: SF/Ala Rte: 80 PM: 13.2/13.9File #: 69.28**WELDING INSPECTION REPORT****Resident Engineer:** Siegenthaler, Peter**Address:** 333 Burma Road**City:** Oakland, CA 94607**Report No:** WIR-016785**Date Inspected:** 05-Sep-2010**Project Name:** SAS Superstructure**OSM Arrival Time:** 1900**Prime Contractor:** American Bridge/Fluor Enterprises, a JV**OSM Departure Time:** 700**Contractor:** Zhenhua Port Machinery Company, Ltd (ZPMC), Changxing Island **Location:** Shanghai, China**CWI Name:** See below**CWI Present:** Yes No**Inspected CWI report:** Yes No N/A**Rod Oven in Use:** Yes No N/A**Electrode to specification:** Yes No N/A**Weld Procedures Followed:** Yes No N/A**Qualified Welders:** Yes No N/A**Verified Joint Fit-up:** Yes No N/A**Approved Drawings:** Yes No N/A**Approved WPS:** Yes No N/A**Delayed / Cancelled:** Yes No N/A**Bridge No:** 34-0006**Component:** OBG Components**Summary of Items Observed:**

Bay 10

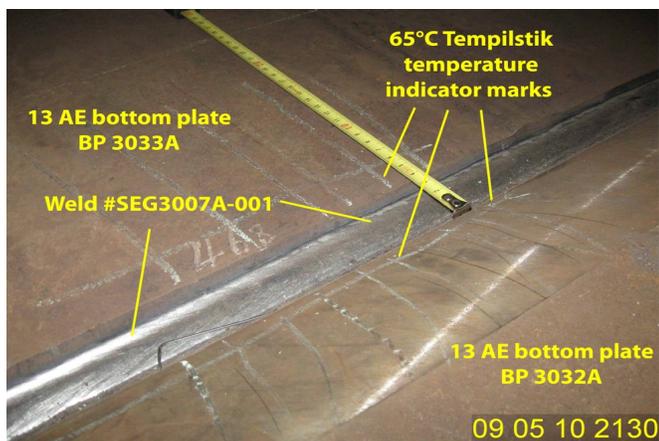
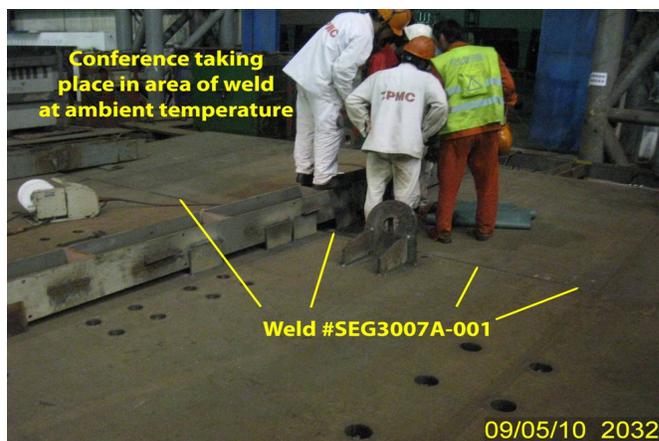
- Butt weld joint SEG3007A-001 which had been performed the previous day at or above a preheat temperature of 110°C and on this day appeared to be unfinished and at ambient temperature, approximately 30°C.
- Multiple 66°C Tempilstik temperature indicator marks applied by this QA Inspector to the adjacent base material within approximately 10mm from the weld did not melt. See photos below.
- The temperature of both plates in the area of the weld was cold to touch.

The above noted issues were not in conformance with contract documents. Note the following reference:

TC-RFI-0075R0, Response: Weld should not be allowed to cool to ambient temperature until all welding is complete.

This QA Inspector notified QC1 and ABF Representative Kelvin Cheung, who was also present at the above noted location, of the above noted non-conforming items and that this QA Inspector would generate an Caltrans Incident Report.
