**DEPARTMENT OF TRANSPORTATION**

Contract #: 04-0120F4Cty: SF/Ala Rte: 80 PM: 13.2/13.9File #: 69.28**WELDING INSPECTION REPORT****Resident Engineer:** Siegenthaler, Peter**Address:** 333 Burma Road**City:** Oakland, CA 94607**Report No:** WIR-016786**Date Inspected:** 10-Sep-2010**Project Name:** SAS Superstructure**OSM Arrival Time:** 1900**Prime Contractor:** American Bridge/Fluor Enterprises, a JV**OSM Departure Time:** 700**Contractor:** Zhenhua Port Machinery Company, Ltd (ZPMC), Changxing Island **Location:** Shanghai, China**CWI Name:** See below**CWI Present:** Yes No**Inspected CWI report:** Yes No N/A**Rod Oven in Use:** Yes No N/A**Electrode to specification:** Yes No N/A**Weld Procedures Followed:** Yes No N/A**Qualified Welders:** Yes No N/A**Verified Joint Fit-up:** Yes No N/A**Approved Drawings:** Yes No N/A**Approved WPS:** Yes No N/A**Delayed / Cancelled:** Yes No N/A**Bridge No:** 34-0006**Component:** Tower and OBG Components**Summary of Items Observed:**

# WELDING INSPECTION REPORT

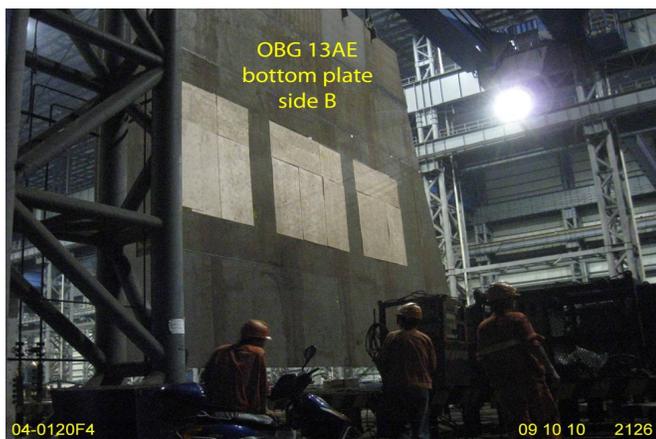
ABF Representative Kelvin Cheung notified this QA Inspector that weld joint SEG3007AC-002, side B located on PCMK OBG segment 13AE, bottom plate was finished and ABF MT (magnetic particle testing) technicians would perform 100% MT on the weld before rotating the plate to bring side A facing upward. This QA Inspector witnessed the ABF technicians perform MT of the weld joint, then this QA Inspector performed random VT (visual testing) and MT on the weld before the plate was rotated to side A facing upward. ABF MT technicians and this QA Inspector concurred that no apparent indications were observed. See photo below of OBG 13AE bottom plate being lifted for rotation.
