Contract #: 04-0120F4Cty: SF/ALA Rte: 80 PM: 13.2/13.9File #: 99.28**WELDING INSPECTION REPORT**

**Report No:** WIR-016800  
**Date Inspected:** 14-Sep-2010

**Project Name:** SAS Superstructure **OSM Arrival Time:** 700  
**Prime Contractor:** American Bridge/Fluor Enterprises, a JV **OSM Departure Time:** 1900  
**Contractor:** Zhenhua Port Machinery Company, Ltd (ZPMC) **Location:** Shanghai, China

<b>CWI Name:</b>	N/A	<b>CWI Present:</b>	<b>Yes</b>	<b>No</b>
<b>Inspected CWI report:</b>	<b>Yes</b> <b>No</b> <b>N/A</b>	<b>Rod Oven in Use:</b>	<b>Yes</b>	<b>No</b> <b>N/A</b>
<b>Electrode to specification:</b>	<b>Yes</b> <b>No</b> <b>N/A</b>	<b>Weld Procedures Followed:</b>	<b>Yes</b>	<b>No</b> <b>N/A</b>
<b>Qualified Welders:</b>	<b>Yes</b> <b>No</b> <b>N/A</b>	<b>Verified Joint Fit-up:</b>	<b>Yes</b>	<b>No</b> <b>N/A</b>
<b>Approved Drawings:</b>	<b>Yes</b> <b>No</b> <b>N/A</b>	<b>Approved WPS:</b>	<b>Yes</b>	<b>No</b> <b>N/A</b>
		<b>Delayed / Cancelled:</b>	<b>Yes</b>	<b>No</b> <b>N/A</b>
<b>Bridge No:</b>	34-0006	<b>Component:</b>	OBG Trial Assembly

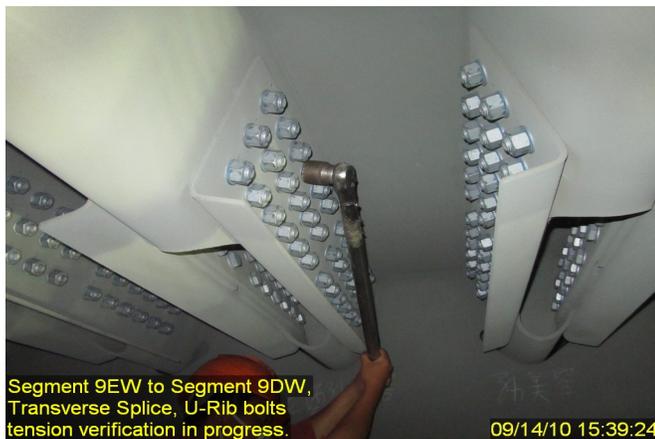
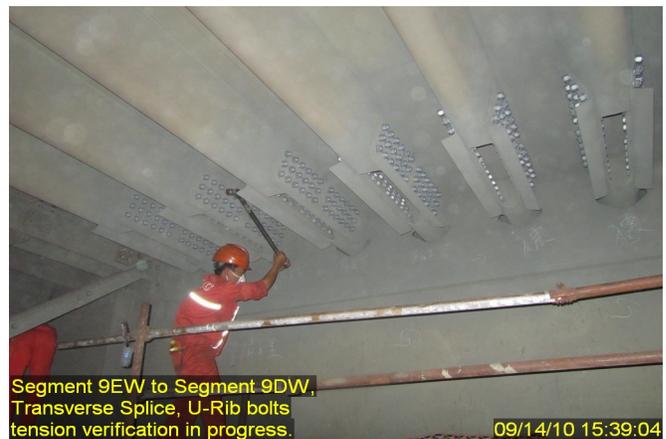
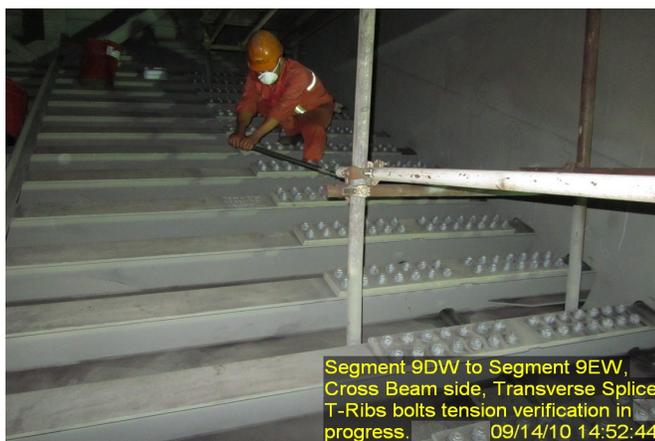
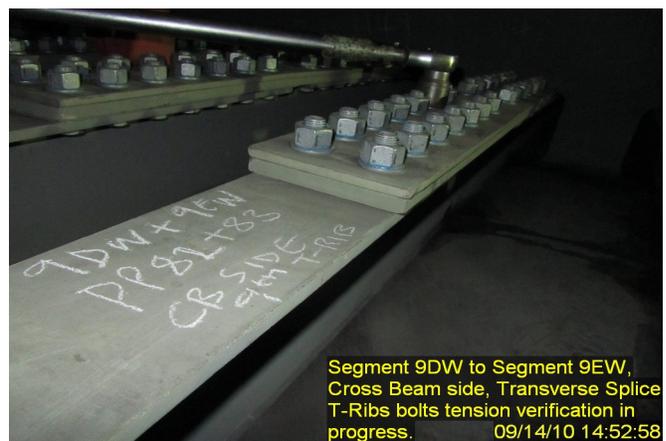
This QA Inspector witnessed the final bolt tension verification on bolts connecting the U-Rib to U-Rib at the transverse splice between Panel Points (PP) 79 and PP 80 for Segment 9CW to Segment 9DW. The QA Inspector verified the bolt tension on a random basis and the results appeared to be in general compliance. The Inspection was performed against Notification No. 00491 dated September 14, 2010.

The bolt sizes used were M22 x 70 RC Lot # DHGM220027 and the final torque value established was 450 N-m.  
The bolt sizes used were M22 x 70 RC Lot # DHGM220028 and the final torque value established was 440 N-m.  
The bolt sizes used were M22 x 70 RC Lot # DHGM220022 and the final torque value established was 487 N-m.  
The bolt sizes used were M22 x 80 RC Lot # DHGM220091 and the final torque value established was 460 N-m.  
The bolt sizes used were M22 x 85 RC Lot # DHGM220111 and the final torque value established was 340 N-m.

This QA Inspector witnessed the final bolt tension verification on bolts connecting the U-Rib to U-Rib at the transverse splice between Panel Points (PP) 82 and PP 83 for Segment 9DW to Segment 9EW. The QA Inspector verified the bolt tension on a random basis and the results appeared to be in general compliance. The Inspection was performed against Notification No. 00491 dated September 14, 2010.

The bolt sizes used were M22 x 70 RC Lot # DHGM220022 and the final torque value established was 487 N-m.  
The bolt sizes used were M22 x 80 RC Lot # DHGM220091 and the final torque value established was 460 N-m.  
The bolt sizes used were M22 x 85 RC Lot # DHGM220111 and the final torque value established was 340 N-m.

towards W3) and Counter Weight side (from work point W3 to W1) between Panel Point (PP) 82 to PP 83 for Segment 9DW to Segment 9EW. Inspected the bolt tensioning on a random basis and found the tension to be in general compliance. Inspection was performed against the Notification 00491 Dated September 14, 2010.

The bolt sizes used were M22 x 65 RC Lot # DHGM220092 and the final torque value established was 466 N-m.

The bolt sizes used were M22 x 65 RC Lot # DHGM220021 and the final torque value established was 543 N-m.

The bolt sizes used were M22 x 70 RC Lot # DHGM220038 and the final torque value established was 480 N-m.

The bolt sizes used were M22 x 80 RC Lot # DHGM220091 and the final torque value established was 460 N-m.

The Manual Torque wrench used was Serial No. XO2-676. Please reference the pictures attached for more comprehensive details.
