DEPARTMENT OF TRANSPORTATION

Quality Assurance and Source Inspection

Contract #: 04-0120F4Cty: SF/ALA Rte: 80 PM: 13.2/13.9File #: 69.28**WELDING INSPECTION REPORT****Resident Engineer:** Siegenthaler, Peter**Address:** 333 Burma Road**City:** Oakland, CA 94607**Report No:** WIR-016822**Date Inspected:** 04-Sep-2010**Project Name:** SAS Superstructure**OSM Arrival Time:** 700**Prime Contractor:** American Bridge/Fluor Enterprises, a JV**OSM Departure Time:** 1900**Contractor:** Zhenhua Port Machinery Company, Ltd (ZPMC), Changxing Island **Location:** Shanghai, China**CWI Name:** Xu tao / Wang jie**CWI Present:** Yes No**Inspected CWI report:** Yes No N/A**Rod Oven in Use:** Yes No N/A**Electrode to specification:** Yes No N/A**Weld Procedures Followed:** Yes No N/A**Qualified Welders:** Yes No N/A**Verified Joint Fit-up:** Yes No N/A**Approved Drawings:** Yes No N/A**Approved WPS:** Yes No N/A**Delayed / Cancelled:** Yes No N/A**Bridge No:** 34-0006**Component:** OBG Components**Summary of Items Observed:**

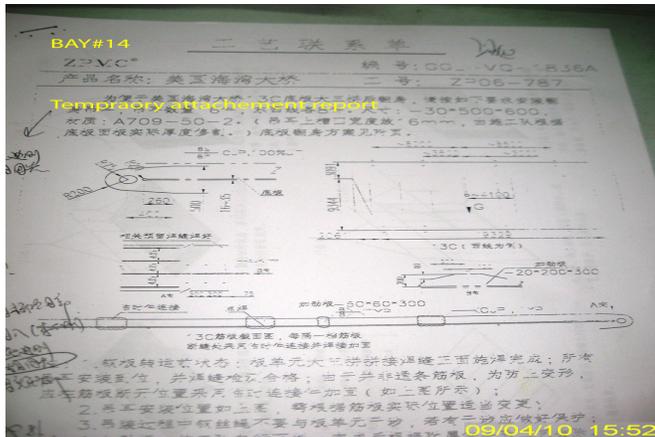
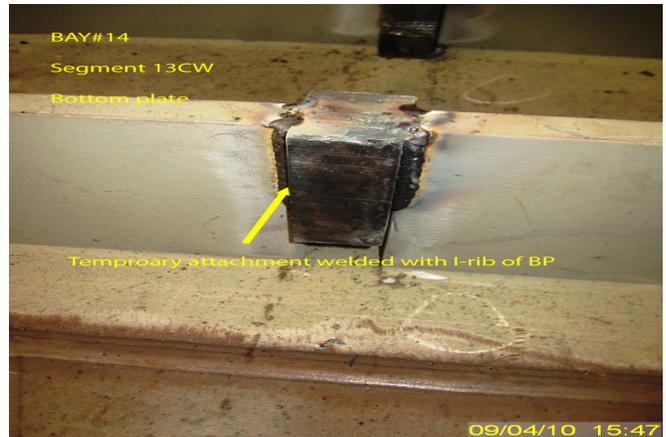
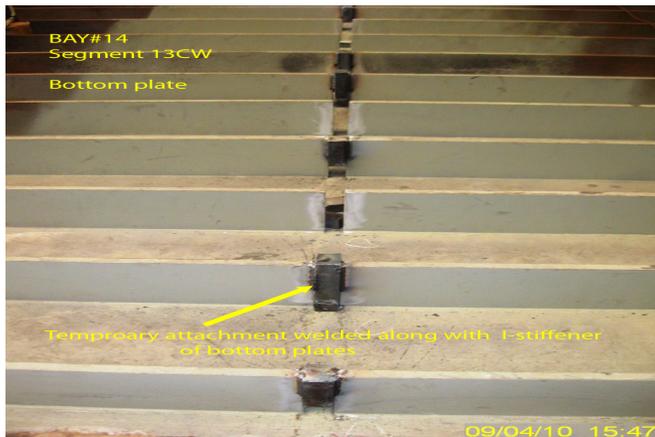
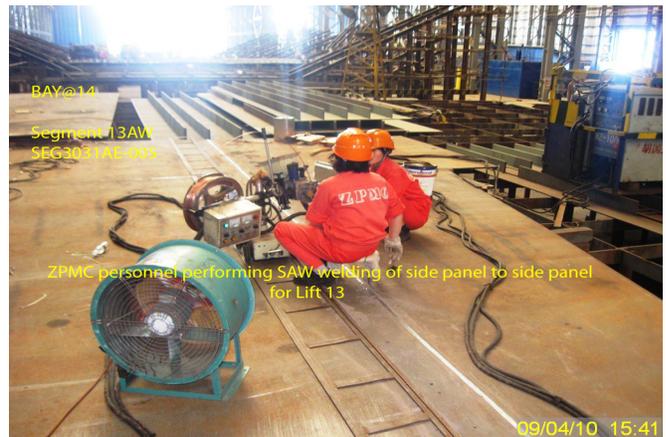
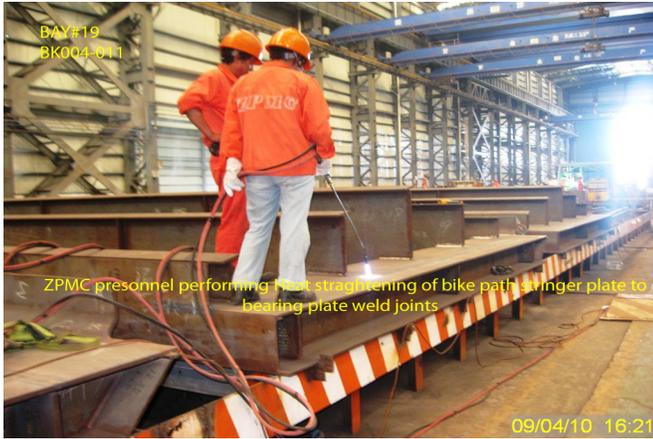
Without any Engineer Approval temporary attachments welded to the I-ribs of Bottom plate in segment 13CW. See the attached photos.
