**DEPARTMENT OF TRANSPORTATION**

Contract #: 04-0120F4Cty: SF/ALA Rte: 80 PM: 13.2/13.9File #: 1.28**WELDING INSPECTION REPORT****Resident Engineer:** Siegenthaler, Peter**Address:** 333 Burma Road**City:** Oakland, CA 94607**Report No:** WIR-016830**Date Inspected:** 17-Sep-2010**Project Name:** SAS Superstructure**OSM Arrival Time:** 830**Prime Contractor:** American Bridge/Fluor Enterprises, a JV**OSM Departure Time:** 1700**Contractor:** American Bridge/Fluor Enterprises, a JV**Location:** Job Site

## WELDING INSPECTION REPORT

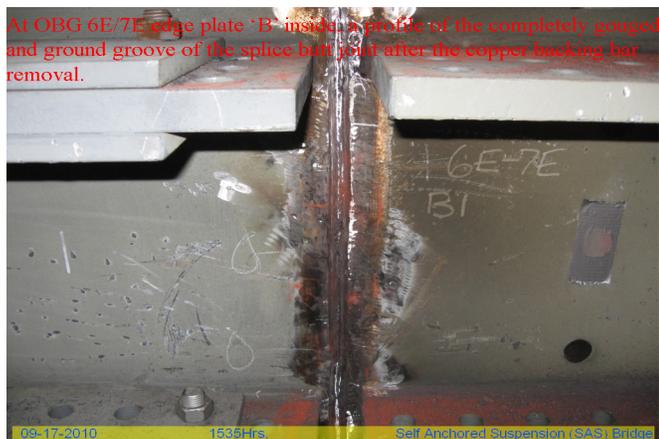
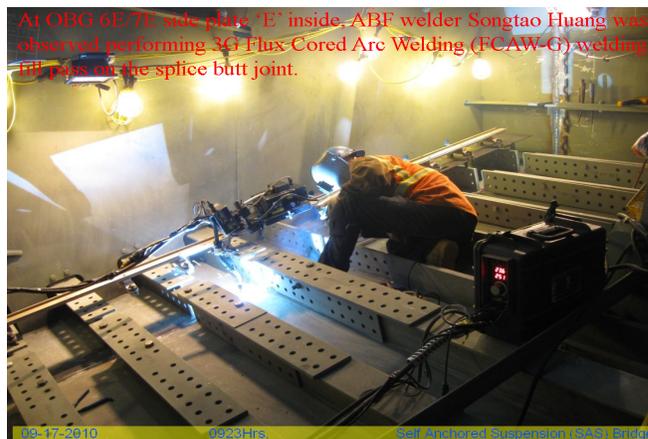
Other activities observed during the shift include flush grinding of the weld cover reinforcement of the welded splice butt joint at OBG 4W/5W bottom plate 'D' outside and the ongoing preparation of ABF welders Rory Hogan and Jeremy Dolman for the 4G FCAW-G back welding of the splice butt joint at OBG 5W/6W side plate 'E' outside.

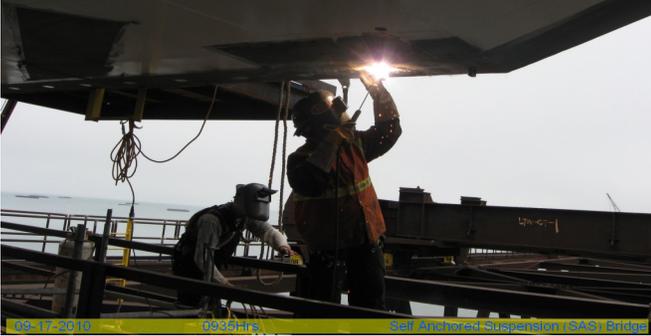
At OBG 6W bottom plate 'D' outside, ABF welder Mike Maday was observed performing 4F fillet welding on the fitting gear/temporary attachment to be used as an aid in the installation of the splice backing bar.

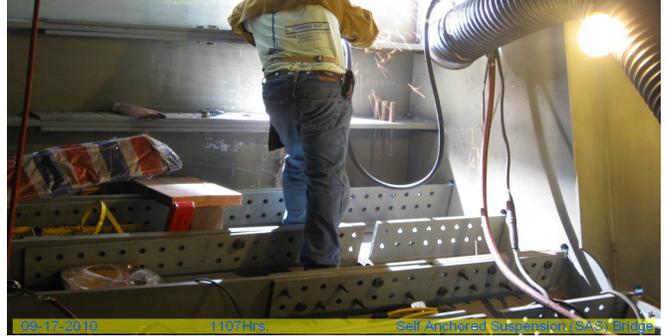
At OBG 6E/7E edge-plate 'B' inside, ABF welder Xiao Jian Wan was observed performing carbon arc gouging on the backing of the welded splice butt joint. The welder had used copper backing bar during the welding from the other side outside.
