Quality Assurance and Source Inspection

Contract #: 04-0120F4Cty: SF/ALA Rte: 80 PM: 13.2/13.9File #: 1.28**WELDING INSPECTION REPORT****Resident Engineer:** Siegenthaler, Peter**Address:** 333 Burma Road**City:** Oakland, CA 94607**Report No:** WIR-016858**Date Inspected:** 20-Sep-2010**Project Name:** SAS Superstructure**OSM Arrival Time:** 700**Prime Contractor:** American Bridge/Fluor Enterprises, a JV**OSM Departure Time:** 1530**Contractor:** American Bridge/Fluor Enterprises, a JV**Location:** Jobsite**CWI Name:** See below**CWI Present:** Yes No**Inspected CWI report:** Yes No N/A**Rod Oven in Use:** Yes No N/A**Electrode to specification:** Yes No N/A**Weld Procedures Followed:** Yes No N/A**Qualified Welders:** Yes No N/A**Verified Joint Fit-up:** Yes No N/A**Approved Drawings:** Yes No N/A**Approved WPS:** Yes No N/A**Delayed / Cancelled:** Yes No N/A**Bridge No:** 34-0006**Component:** SAS OBG**Summary of Items Observed:**

- 1). OBG Field Splice 4W/5W Weld ID: C1 & C2, Face A (SMAW Repairs)
- 2). OBG Field Splice 4W/5W Weld E1 & E2, Face A (QAI Verification)
- 3). OBG Field Splice 5W/6W Weld E2, Face B (FCAW-G)
- 4). OBG Field Splice 6E/7E weld ID: B1, Face B (SMAW)
-

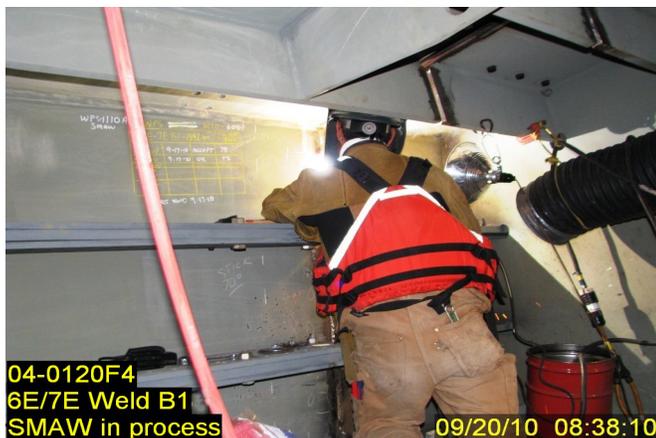
4). OBG Field Splice 6E/7E weld ID: B1, Face B (SMAW)

The QAI periodically observed the in process welding of OBG Field Splice 6E/7E weld ID: B1, on the B Face (interior) per the SMAW process in the 3G (vertical) position by ABF welding personnel James Zhen (ID 6001). See photo below. QC Inspector John Pasqualone was present to monitor the progress and verify that the welding parameters were within the limits established by the approved welding Procedure Specification (WPS) identified as ABF-WPS-D1.5-1110-A. The work at this location was in process during this shift. The QAI observed that work at this location appeared to be in general compliance with the contract documents.

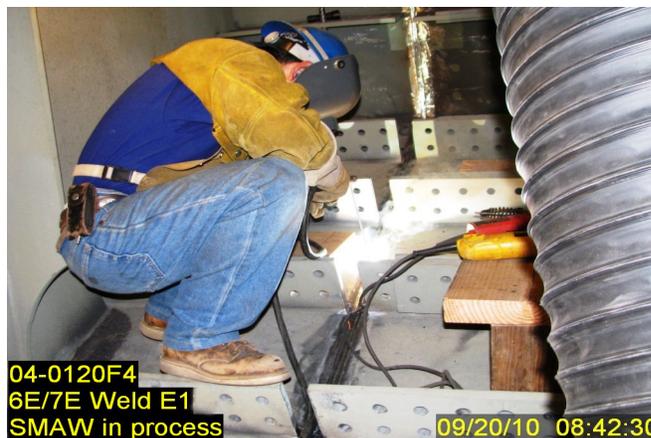
5). OBG Field Splice 6E/7E weld ID: E1, Face A (SMAW)

The QAI periodically observed the in process welding of OBG Field Splice 6E/7E weld ID: E1, on the A Face (interior) per the SMAW process in the 3G (vertical) position by ABF welding personnel Xiao Jian Wan (ID 9677). See photo below. QC Inspector John Pasqualone was present to monitor the progress and verify that the welding parameters were within the limits established by the approved welding Procedure Specification (WPS) identified as ABF-WPS-D1.5-1110-A. The work at this location was in process during this shift. The QAI observed that work at this location appeared to be in general compliance with the contract documents.
