Contract #: 04-0120F4Cty: SF/ALA Rte: 80 PM: 13.2/13.9File #: 69.28**WELDING INSPECTION REPORT****Resident Engineer:** Pursell, Gary**Address:** 333 Burma Road**City:** Oakland, CA 94607**Report No:** WIR-016918**Date Inspected:** 16-Aug-2010**Project Name:** SAS Superstructure**OSM Arrival Time:** 700**Prime Contractor:** American Bridge/Fluor Enterprises, a JV**OSM Departure Time:** 1900**Contractor:** Zhenhua Port Machinery Company, Ltd (ZPMC), Changxing Island **Location:** Shanghai, China**CWI Name:** Xu Tao**CWI Present:** Yes No**Inspected CWI report:** Yes No N/A**Rod Oven in Use:** Yes No N/A**Electrode to specification:** Yes No N/A**Weld Procedures Followed:** Yes No N/A**Qualified Welders:** Yes No N/A**Verified Joint Fit-up:** Yes No N/A**Approved Drawings:** Yes No N/A**Approved WPS:** Yes No N/A**Delayed / Cancelled:** Yes No N/A**Bridge No:** 34-0006**Component:** OBG COMPONENT**Summary of Items Observed:**

WELDING INSPECTION REPORT

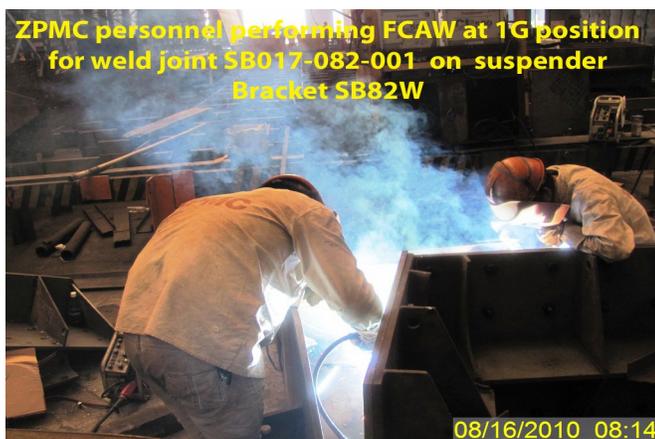
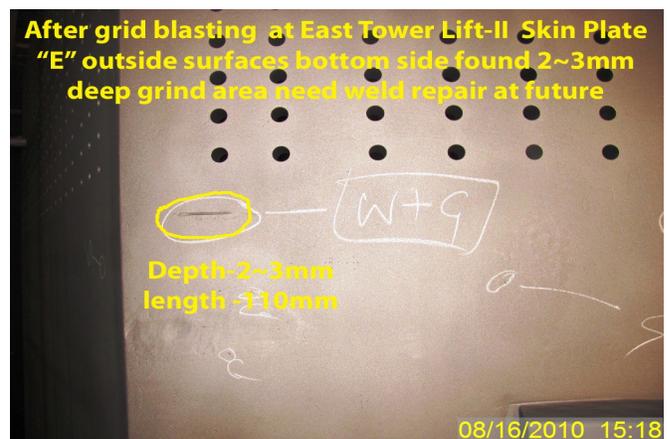
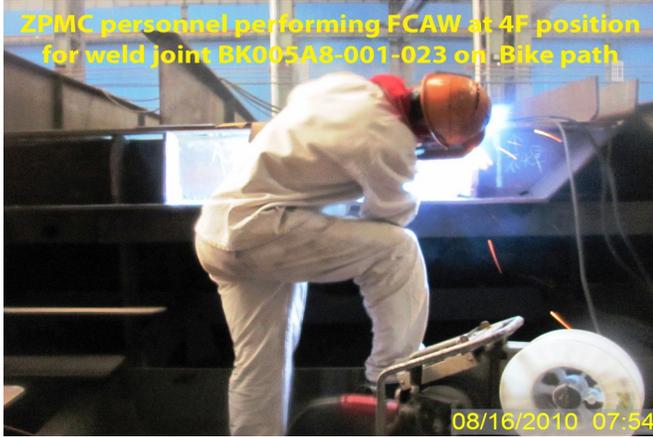
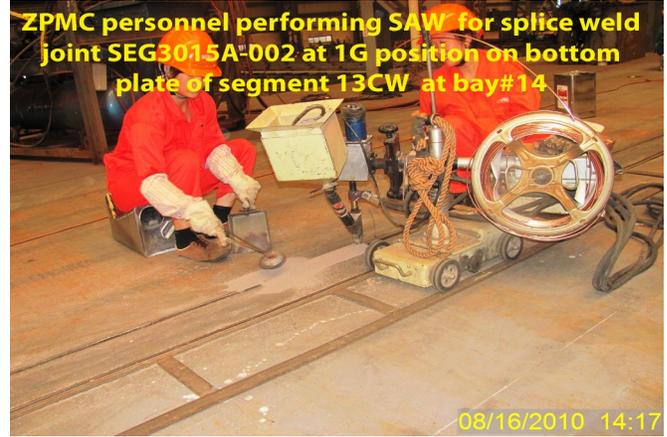
FCAW in the 1G position for the OBG suspender Bracket SB82W, weld No. SB017-082-001. The welder is identified as #062761. ZPMC QC is identified as Mr. Xu Tao. The welding variables recorded by QC appear to comply with WPS-B-T-2231-Tc-U4b-F.

FCAW in the 2F position for the OBG Bike Path, weld No. BK005A6-001-021/022. The welder is identified as #208641. ZPMC QC is identified as Mr. Xu Tao. The welding variables recorded by QC appear to comply with WPS-B-T-2132.

FCAW in the 4F position for the OBG Bike Path, weld No. BK005A8-001-023/024. The welder is identified as #500909. ZPMC QC is identified as Mr. Xu Tao. The welding variables recorded by QC appear to comply with WPS-B-T-2134.

FCAW in the 2F position for the OBG Bike Path, weld No. BK004A3-011-071/072. The welder is identified as #062783. ZPMC QC is identified as Mr. Xu Tao. The welding variables recorded by QC appear to comply with

FCAW in the 2F position for the OBG segment 12CW, weld No. SEG3004B-058~085. The welder is identified as #201583. ZPMC QC is identified as Mr. Wang Wai Ming . The welding variables recorded by QC appear to comply with WPS-B-T-2132.

SMAW in the 4F position for the OBG segment 12AW, weld No. SEG3004V-058/059. The welder is identified as #067589. ZPMC QC is identified as Mr. Wang Wai Ming . The welding variables recorded by QC appear to comply with WPS-B-P-2114-FCM-1.

SAW in the 1G position for the OBG Segment 13CE, weld No. SEG3011A-002. The welder is identified as #044771. ZPMC QC is identified as Mr. Zhang Ling. The welding variables recorded by QC appear to comply with WPS-B-T-2221-B-L2c-S-2.

SAW in the 1G position for the OBG Segment 13CW, weld No. SEG3015A-002. The welder is identified as #045270. ZPMC QC is identified as Mr. Guo Xing Hui. The welding variables recorded by QC appear to comply with WPS-B-T-2221-B-L2c-S-2.

This Quality Assurance (QA) Inspector performed random visual inspection of East Tower Lift-II outside Skin Plate A to E surfaces after grit blasting. Areas that marked for repair were recorded for future repair. And some areas requiring additional grinding were marked by QA Inspector and repaired by ZPMC personnel.
