DEPARTMENT OF TRANSPORTATION

Contract #: 04-0120F4Cty: SF/ALA Rte: 80 PM: 13.2/13.9File #: 1.28**WELDING INSPECTION REPORT****Resident Engineer:** Siegenthaler, Peter**Address:** 333 Burma Road**City:** Oakland, CA 94607**Report No:** WIR-016926**Date Inspected:** 23-Sep-2010**Project Name:** SAS Superstructure**OSM Arrival Time:** 700**Prime Contractor:** American Bridge/Fluor Enterprises, a JV**OSM Departure Time:** 1530**Contractor:** American Bridge/Fluor Enterprises, a JV**Location:** Jobsite**CWI Name:** See below**CWI Present:** Yes No**Inspected CWI report:** Yes No N/A**Rod Oven in Use:** Yes No N/A**Electrode to specification:** Yes No N/A**Weld Procedures Followed:** Yes No N/A**Qualified Welders:** Yes No N/A**Verified Joint Fit-up:** Yes No N/A**Approved Drawings:** Yes No N/A**Approved WPS:** Yes No N/A**Delayed / Cancelled:** Yes No N/A**Bridge No:** 34-0006**Component:** SAS OBG**Summary of Items Observed:**

WELDING INSPECTION REPORT

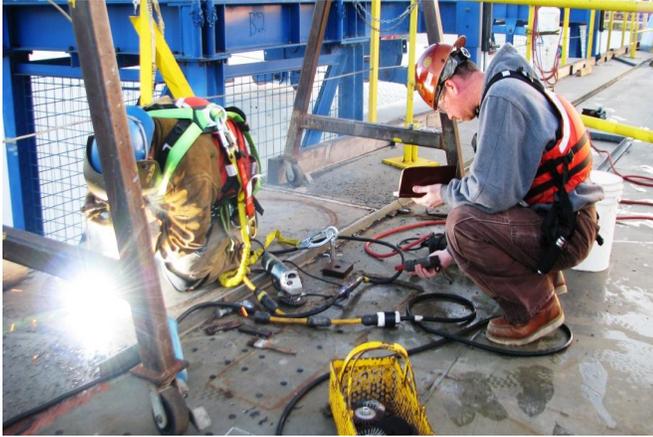
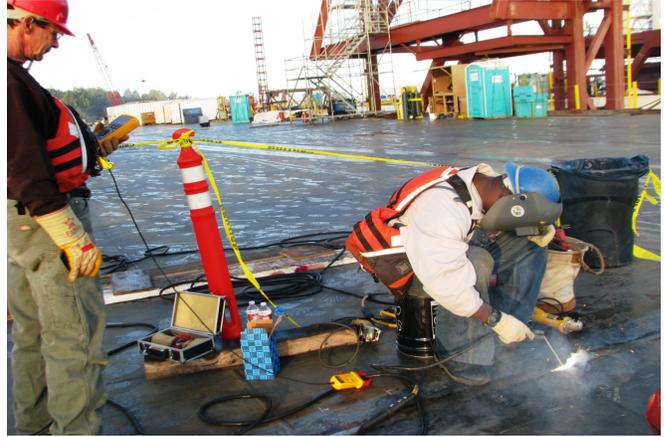
The QAI periodically observed AB/F approved welder Fred Kaddu (ID 2188) performing excavation by grinding of R-1 repair areas identified by QC. The QAI observed QC Inspectors Tom Pasqualone performing MT of the R-1 repair excavations prior to the commencement of welding. The QAI observed that the performance and evaluation of the MT appeared to comply with the MT procedure identified as SE-MT-CT-D1.5-101 Rev. 4. The QAI periodically observed AB/F approved welder Fred Kaddu (ID 2188) performing repair welding of the excavated areas per the Shielded Metal Arc Welding (SMAW) process. QC Inspectors Tom Pasqualone or Steve McConnell were present to monitor the progress and verify that the welding parameters were within the limits

established by the approved welding Procedure Specification (WPS) identified as ABF-WPS-D1.5-1000-Repair. See photo below. The excavating and repair welding was in process and the work at this location appeared to be in general compliance with contract documents.
