DEPARTMENT OF TRANSPORTATION

Quality Assurance and Source Inspection

Contract #: 04-0120F4Cty: SF/ALA Rte: 80 PM: 13.2/13.9File #: 69.28**WELDING INSPECTION REPORT****Resident Engineer:** Siegenthaler, Peter**Address:** 333 Burma Road**City:** Oakland, CA 94607**Report No:** WIR-017007**Date Inspected:** 10-Sep-2010**Project Name:** SAS Superstructure**OSM Arrival Time:** 1900**Prime Contractor:** American Bridge/Fluor Enterprises, a JV**OSM Departure Time:** 700**Contractor:** Zhenhua Port Machinery Company, Ltd (ZPMC), Changxing Island **Location:** Shanghai, China**CWI Name:** See Below**CWI Present:** Yes No**Inspected CWI report:** Yes No N/A**Rod Oven in Use:** Yes No N/A**Electrode to specification:** Yes No N/A**Weld Procedures Followed:** Yes No N/A**Qualified Welders:** Yes No N/A**Verified Joint Fit-up:** Yes No N/A**Approved Drawings:** Yes No N/A**Approved WPS:** Yes No N/A**Delayed / Cancelled:** Yes No N/A**Bridge No:** 34-0006**Component:** OBG**Summary of Items Observed:**

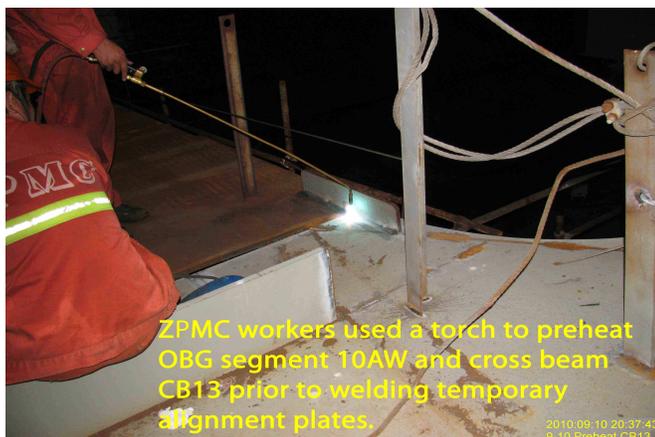
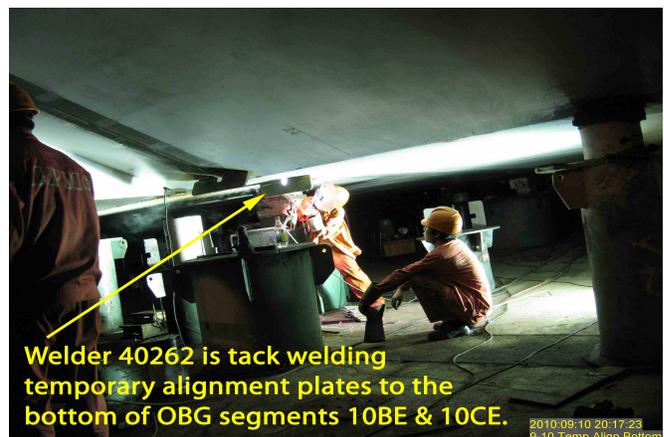
This QA Inspector observed ZPMC welder Mr. Li Hongren, stencil 062200 used shielded metal arc process to tack weld a weld temporary alignment plate to OBG segment 10AW and cross beam CB14 top deck plates. This QA Inspector measured a welding current of approximately 170 amps, the base material adjacent to this weld appeared to have been preheated with torch and Mr. Li Hongren appeared to be certified to perform this welding. Items observed on this date appeared to generally comply with applicable contract documents.
