Contract #: 04-0120F4Cty: SF/ALA Rte: 80 PM: 13.2/13.9File #: 69.28**WELDING INSPECTION REPORT****Resident Engineer:** Siegenthaler, Peter**Address:** 333 Burma Road**City:** Oakland, CA 94607**Report No:** WIR-017028**Date Inspected:** 24-Sep-2010**Project Name:** SAS Superstructure**OSM Arrival Time:** 1900**Prime Contractor:** American Bridge/Fluor Enterprises, a JV**OSM Departure Time:** 700**Contractor:** Zhenhua Port Machinery Company, Ltd (ZPMC), Changxing Island **Location:** Shanghai, China**CWI Name:** See Below**CWI Present:** Yes No**Inspected CWI report:** Yes No N/A**Rod Oven in Use:** Yes No N/A**Electrode to specification:** Yes No N/A**Weld Procedures Followed:** Yes No N/A**Qualified Welders:** Yes No N/A**Verified Joint Fit-up:** Yes No N/A**Approved Drawings:** Yes No N/A**Approved WPS:** Yes No N/A**Delayed / Cancelled:** Yes No N/A**Bridge No:** 34-0006**Component:** OBG**Summary of Items Observed:**

OBG Segment Trial Assembly

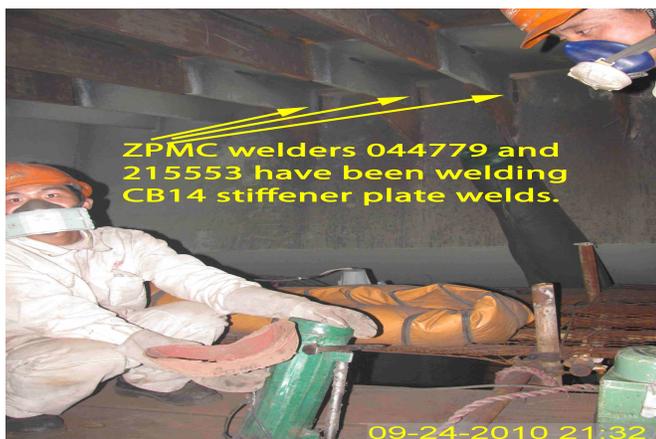
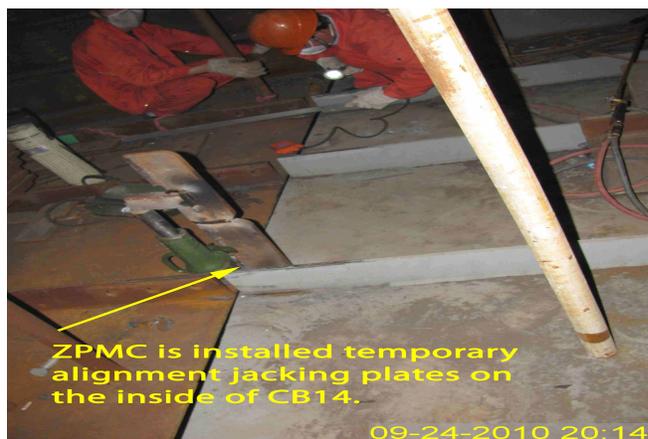
being misaligned on weld repair document B-CWR1930. The welds are located inside cross beam CB14 adjacent to OBG segment 10AW deck plate near panel point PP086. This QA Inspector observed Mr. Yang Yunfeng appeared to be certified to make this weld and this QA Inspector measured a welding current of approximately 170 amps. Items observed on this date appeared to generally comply with applicable contract documents.

This QA Inspector observed ZPMC welder Mr. Zhao Guanglin, stencil 044779 is using shielded metal welding procedure WPS-345-SMAW-3G(3F)-Repair to make OBG SEG060D stiffener plate welds which was identified as being misaligned on weld repair document B-CWR1930. The welds are located inside cross beam CB14 adjacent to OBG segment 10AW deck plate near panel point PP086. This QA Inspector observed Mr. Zhao Guanglin appeared to be certified to make this weld and this QA Inspector measured a welding current of approximately 165 amps. Items observed on this date appeared to generally comply with applicable contract documents.

This QA Inspector observed ZPMC welder Mr. Wang Zheng Bin, stencil 216086 is using shielded metal welding procedure WPS-345-SMAW-3G(3F)-Repair to make OBG SEG060D stiffener plate welds which was identified as being misaligned on weld repair document B-CWR1930. The welds are located inside cross beam CB14 adjacent to OBG segment 10AW deck plate near panel point PP088. This QA Inspector observed Mr. Wang Zheng Bin appeared to be certified to make this weld and this QA Inspector observed ZPMC QC has recorded a welding current of 145 amps. Items observed on this date appeared to generally comply with applicable contract documents.
