DEPARTMENT OF TRANSPORTATION

Quality Assurance and Source Inspection

Contract #: 04-0120F4Cty: SF/ALA Rte: 80 PM: 13.2/13.9File #: 69.28**WELDING INSPECTION REPORT****Resident Engineer:** Siegenthaler, Peter**Address:** 333 Burma Road**City:** Oakland, CA 94607**Report No:** WIR-017064**Date Inspected:** 28-Sep-2010**Project Name:** SAS Superstructure**OSM Arrival Time:** 645**Prime Contractor:** American Bridge/Fluor Enterprises, a JV**OSM Departure Time:** 1845**Contractor:** Zhenhua Port Machinery Company, Ltd (ZPMC), Changxing Island **Location:** Shanghai, China**CWI Name:** Chen Xi.**CWI Present:** Yes No**Inspected CWI report:** Yes No N/A**Rod Oven in Use:** Yes No N/A**Electrode to specification:** Yes No N/A**Weld Procedures Followed:** Yes No N/A**Qualified Welders:** Yes No N/A**Verified Joint Fit-up:** Yes No N/A**Approved Drawings:** Yes No N/A**Approved WPS:** Yes No N/A**Delayed / Cancelled:** Yes No N/A**Bridge No:** 34-0006**Component:** Orthotropic Box Girder (OBG)**Summary of Items Observed:**

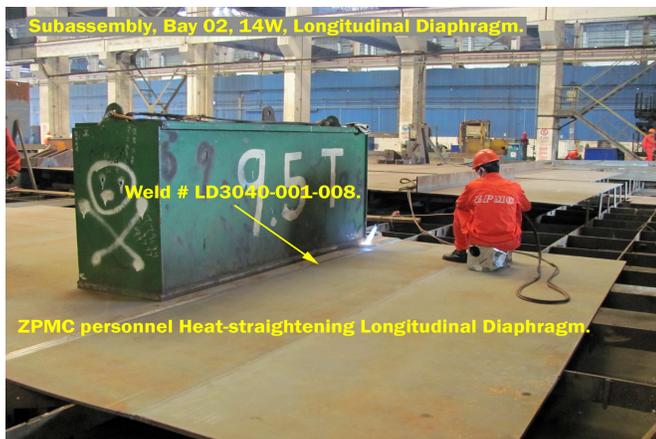
Subassembly, Bay 02, 14W, Longitudinal Diaphragm.

During Random Visual in process Inspection, this QA inspector observed ZPMC personnel Heat-straightening Longitudinal Diaphragm. Longitudinal Diaphragm weld being Flame heated is identified as LD3040-001-008. Heat Straightening report (HSR) number identified as HSR1(B)-9465. The attached photographs provide additional detail.
