**DEPARTMENT OF TRANSPORTATION**

Contract #: 04-0120F4Cty: SF/ALA Rte: 80 PM: 13.2/13.9File #: 1.28**WELDING INSPECTION REPORT****Resident Engineer:** Siegenthaler, Peter**Address:** 333 Burma Road**City:** Oakland, CA 94607**Report No:** WIR-017071**Date Inspected:** 28-Sep-2010**Project Name:** SAS Superstructure**OSM Arrival Time:** 700**Prime Contractor:** American Bridge/Fluor Enterprises, a JV**OSM Departure Time:** 1530**Contractor:** American Bridge/Fluor Enterprises, a JV**Location:** Jobsite**CWI Name:** See below**CWI Present:** Yes No**Inspected CWI report:** Yes No N/A**Rod Oven in Use:** Yes No N/A**Electrode to specification:** Yes No N/A**Weld Procedures Followed:** Yes No N/A**Qualified Welders:** Yes No N/A**Verified Joint Fit-up:** Yes No N/A**Approved Drawings:** Yes No N/A**Approved WPS:** Yes No N/A**Delayed / Cancelled:** Yes No N/A**Bridge No:** 34-0006**Component:** SAS OBG**Summary of Items Observed:**

## WELDING INSPECTION REPORT

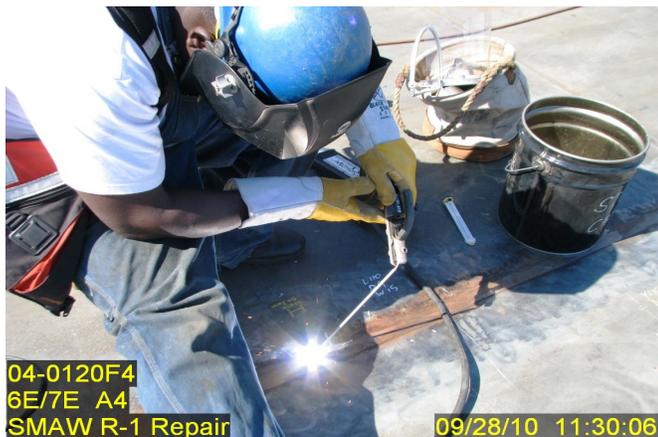
The QAI observed QC Inspector Steve McConnell performing UT to confirm the rejectable UT indication

identified by the QAI earlier in the shift at OBG Field Splice 6E/7E Weld ID: A4. See photo below. The QAI observed that Mr. McConnell utilized the UT Procedure identified as SE-UT-D1.5-CT-100 Rev.4 during the examination of the splice weld. See photo below. The QC technician performed the required shear wave testing during the testing for weld soundness utilizing a .63 x .75 rectangular transducer. The UT examination was completed and the QC Mr. McConnell concurred with the QAI UT results that the indication was a Class A reject and the QC inspector then laid out the indication for repair.

The QAI periodically observed AB/F approved welder Fred Kaddu performing grinding to excavate (1) one 27mm long R-1 repair located at Y = 290mm. The QC Inspector stated to the QAI that porosity had been observed as the excavation was in process. The QAI observed QC Inspector Tony Sherwood performing Magnetic Particle Testing (MT) of the R-1 repair excavation prior to the commencement of repair welding. The QAI observed that the performance and evaluation of the MT appeared to comply with the MT procedure identified as SE-MT-CT-D1.5-101 Rev. 4. The QAI then periodically observed AB/F approved welder Fred Kaddu (ID 2188) performing repair welding of the excavated area per the SMAW process in the 1G (flat) position. See photo below. QC Inspector Tony Sherwood was present to monitor the progress and verify that the welding parameters were within the limits established by the approved welding Procedure Specification (WPS) identified as ABF-WPS-D1.5-1000-Repair. The repair welding was completed at this location and the work appeared to be in general compliance with contract documents.

The QAI located QC Inspector Tom Pasqualone and informed him that the QAI had identified a rejectable indication in the 6E/7E weld A4. Mr. Pasqualone observed while the QAI performed UT and relocated the rejectable reflector. Mr. Pasqualone stated that he would need to find a welder to repair the area. The QAI stated to Mr. Pasqualone that a QC technician would need to confirm the QAI UT finding and generate a QC report from which the repair welding could be based upon. Mr. Pasqualone stated that either he or QC Steve McConnell would re-inspect the area.
