DEPARTMENT OF TRANSPORTATION

Contract #: 04-0120F4Cty: SF/ALA Rte: 80 PM: 13.2/13.9File #: 69.28**WELDING INSPECTION REPORT****Resident Engineer:** Siegenthaler, Peter**Address:** 333 Burma Road**City:** Oakland, CA 94607**Report No:** WIR-017163**Date Inspected:** 29-Sep-2010**Project Name:** SAS Superstructure**OSM Arrival Time:** 700**Prime Contractor:** American Bridge/Fluor Enterprises, a JV**OSM Departure Time:** 1900**Contractor:** Zhenhua Port Machinery Company, Ltd (ZPMC), Changxing Island **Location:** Shanghai, China**CWI Name:** Mr. Lv Li Qing**CWI Present:** Yes No**Inspected CWI report:** Yes No N/A**Rod Oven in Use:** Yes No N/A**Electrode to specification:** Yes No N/A**Weld Procedures Followed:** Yes No N/A**Qualified Welders:** Yes No N/A**Verified Joint Fit-up:** Yes No N/A**Approved Drawings:** Yes No N/A**Approved WPS:** Yes No N/A**Delayed / Cancelled:** Yes No N/A**Bridge No:** 34-0006**Component:** OBG**Summary of Items Observed:**

WELDING INSPECTION REPORT

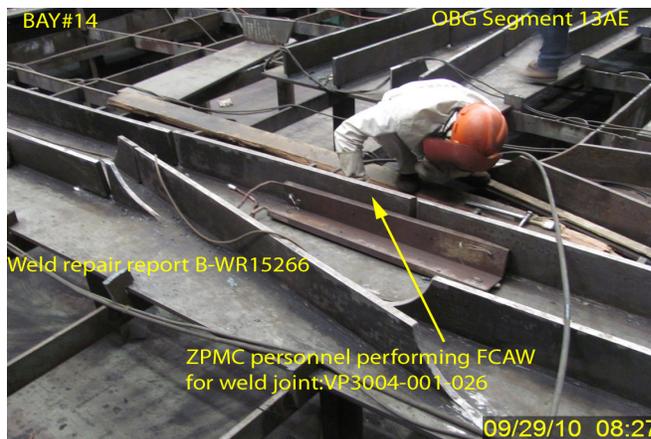
FCAW welding of weld joint no: VP3004-001-026 located on OBG Segment 13AE. Welder is identified as #044795. ZPMC CWI is identified as Mr. Lv Li Qing. Welding was performed according to the weld repair report B-WR15266 and UT report number: B787-UT-15455. The welding variables recorded by QC appeared to comply with the WPS-345-FCAW-2G(2F)-Repair. Please see the attached picture.
