**DEPARTMENT OF TRANSPORTATION**

Contract #: 04-0120F4Cty: SF/ALA Rte: 80 PM: 13.2/13.9File #: 99.28**WELDING INSPECTION REPORT****Resident Engineer:** Siegenthaler, Peter**Address:** 333 Burma Road**City:** Oakland, CA 94607**Report No:** WIR-017187**Date Inspected:** 26-Sep-2010**Project Name:** SAS Superstructure**OSM Arrival Time:** 700**Prime Contractor:** American Bridge/Fluor Enterprises, a JV**OSM Departure Time:** 1900**Contractor:** Zhenhua Port Machinery Company, Ltd (ZPMC) Chanxing Island**Location:** Shanghai, China**CWI Name:** Mr. Xu Tao**CWI Present:** Yes No**Inspected CWI report:** Yes No N/A**Rod Oven in Use:** Yes No N/A**Electrode to specification:** Yes No N/A**Weld Procedures Followed:** Yes No N/A**Qualified Welders:** Yes No N/A**Verified Joint Fit-up:** Yes No N/A**Approved Drawings:** Yes No N/A**Approved WPS:** Yes No N/A**Delayed / Cancelled:** Yes No N/A**Bridge No:** 34-0006**Component:** OBG Bike Path and Segment**Summary of Items Observed:**

## WELDING INSPECTION REPORT

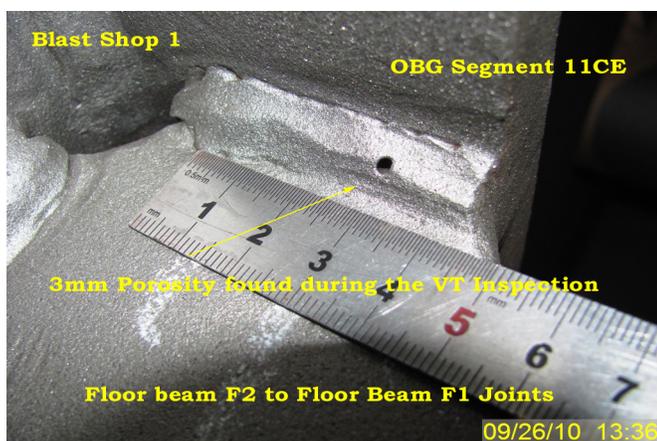
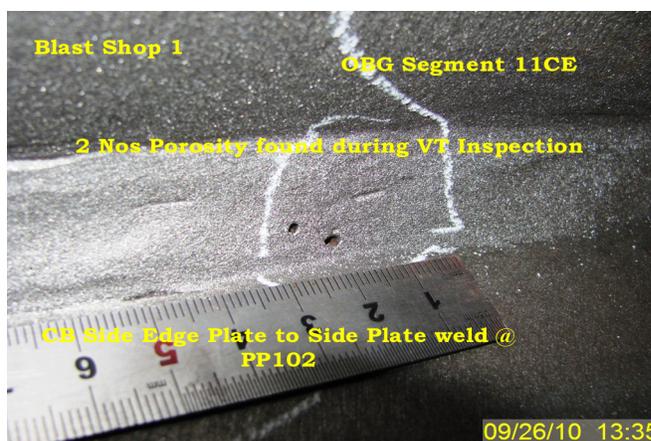
This QA Inspector performed a preliminary random visual inspection on OBG Segment 11CE, after the grit blast of the interior components of the deck panel, floor beams and corner assemblies of this segment. Areas of visual weld defects that will require welding were taped and will be repaired after the coating is applied. ZPMC QC personnel are aware of these areas and were present during the inspection. See the attaches pictures.
