Contract #: 04-0120F4Cty: SF/ALA Rte: 80 PM: 13.2/13.9File #: 1.28**WELDING INSPECTION REPORT****Resident Engineer:** Siegenthaler, Peter**Address:** 333 Burma Road**City:** Oakland, CA 94607**Report No:** WIR-017230**Date Inspected:** 02-Oct-2010**Project Name:** SAS Superstructure**OSM Arrival Time:** 800**Prime Contractor:** American Bridge/Fluor Enterprises, a JV**OSM Departure Time:** 1630**Contractor:** American Bridge/Fluor Enterprises, a JV**Location:** Job Site

CWI Name:	William Sherwood and Jesse Cayabyab			CWI Present:	Yes	No	
Inspected CWI report:	Yes	No	N/A	Rod Oven in Use:	Yes	No	N/A
Electrode to specification:	Yes	No	N/A	Weld Procedures Followed:	Yes	No	N/A
Qualified Welders:	Yes	No	N/A	Verified Joint Fit-up:	Yes	No	N/A
Approved Drawings:	Yes	No	N/A	Approved WPS:	Yes	No	N/A
				Delayed / Cancelled:	Yes	No	N/A
Bridge No:	34-0006			Component:	Orthotropic Box Girder

WELDING INSPECTION REPORT

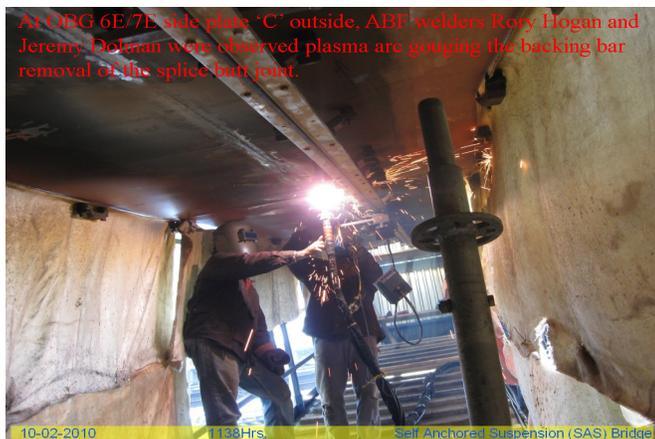
At OBG 6E/7E side plate 'C' outside, QA randomly observed ABF personnel Rory Hogan and Jeremy Dolman perform plasma arc gouging on the backing bar removal of the splice butt joint. The personnel were using an Esab plasma arc gouging machine that has the nozzle holder attached to a Bug-o track. Gouging of the backing bar was not completed today and should continue tomorrow.
