Quality Assurance and Source Inspection

Contract #: 04-0120F4Cty: SF/ALA Rte: 80 PM: 13.2/13.9File #: 69.28**WELDING INSPECTION REPORT****Resident Engineer:** Siegenthaler, Peter**Address:** 333 Burma Road**City:** Oakland, CA 94607**Report No:** WIR-017234**Date Inspected:** 30-Sep-2010**Project Name:** SAS Superstructure**OSM Arrival Time:** 645**Prime Contractor:** American Bridge/Fluor Enterprises, a JV**OSM Departure Time:** 1845**Contractor:** Zhenhua Port Machinery Company, Ltd (ZPMC), Changxing Island **Location:** Shanghai, China**CWI Name:** An Qing Xiang.**CWI Present:** Yes No**Inspected CWI report:** Yes No N/A**Rod Oven in Use:** Yes No N/A**Electrode to specification:** Yes No N/A**Weld Procedures Followed:** Yes No N/A**Qualified Welders:** Yes No N/A**Verified Joint Fit-up:** Yes No N/A**Approved Drawings:** Yes No N/A**Approved WPS:** Yes No N/A**Delayed / Cancelled:** Yes No N/A**Bridge No:** 34-0006**Component:** Orthotropic Box Girder (OBG)**Summary of Items Observed:**

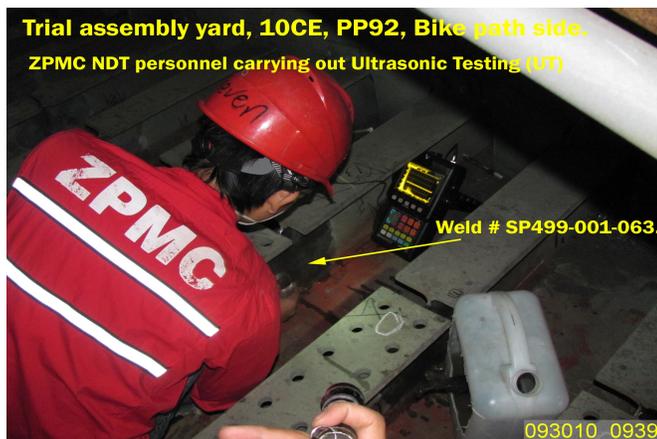
During Random Visual in process Inspection, this QA inspector observed ZPMC NDT personnel carrying out Ultrasonic Testing (UT) on T-rib to T-rib weld 10CE & 10BE. Weld identified as SP499-001-063. The attached photographs provide additional detail.
