Contract #: 04-0120F4Cty: SF/ALA Rte: 80 PM: 13.2/13.9File #: 69.28**WELDING INSPECTION REPORT****Resident Engineer:** Siegenthaler, Peter**Address:** 333 Burma Road**City:** Oakland, CA 94607**Report No:** WIR-017304**Date Inspected:** 07-Oct-2010**Project Name:** SAS Superstructure**OSM Arrival Time:** 1900**Prime Contractor:** American Bridge/Fluor Enterprises, a JV**OSM Departure Time:** 700**Contractor:** Zhenhua Port Machinery Company, Ltd (ZPMC), Changxing Island **Location:** Shanghai, China**CWI Name:** See Below**CWI Present:** Yes No**Inspected CWI report:** Yes No N/A**Rod Oven in Use:** Yes No N/A**Electrode to specification:** Yes No N/A**Weld Procedures Followed:** Yes No N/A**Qualified Welders:** Yes No N/A**Verified Joint Fit-up:** Yes No N/A**Approved Drawings:** Yes No N/A**Approved WPS:** Yes No N/A**Delayed / Cancelled:** Yes No N/A**Bridge No:** 34-0006**Component:** OBG**Summary of Items Observed:**

OBG Segment Trial Assembly

WELDING INSPECTION REPORT

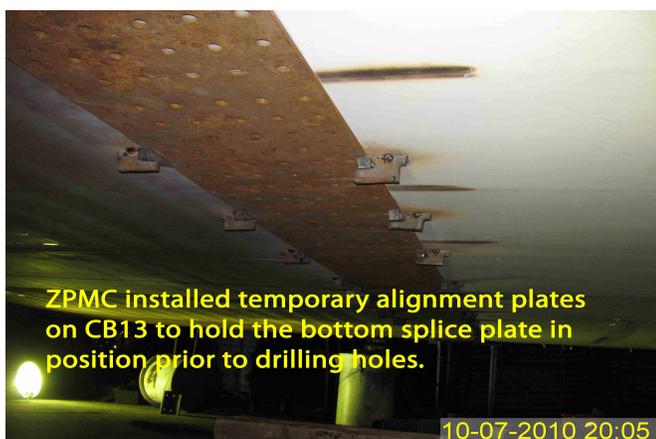
This QA Inspector observed ZPMC welder Mr. Hong Jie Fang, stencil 205758 used shielded metal arc process to tack weld temporary alignment plates on the exterior of OBG cross beam CB13 adjacent to OBG segment 10AW. These welds are being made to hold the splice plate that will be bolted between the bottom surfaces of the cross beam and 10AW bottom plate. This splice plate will be later be bolted to both of these components. This QA Inspector observed Mr. Hong Jie Fang appeared to be certified to perform this welding and the base material appears to have been preheated with a torch. Items observed on this date appeared to generally comply with applicable contract documents. See the photograph below for additional information.
