Quality Assurance and Source Inspection

Contract #: 04-0120F4Cty: SF/ALA Rte: 80 PM: 13.2/13.9File #: 69.28**WELDING INSPECTION REPORT****Resident Engineer:** Siegenthaler, Peter**Address:** 333 Burma Road**City:** Oakland, CA 94607**Report No:** WIR-017305**Date Inspected:** 08-Oct-2010**Project Name:** SAS Superstructure**OSM Arrival Time:** 1900**Prime Contractor:** American Bridge/Fluor Enterprises, a JV**OSM Departure Time:** 700**Contractor:** Zhenhua Port Machinery Company, Ltd (ZPMC), Changxing Island **Location:** Shanghai, China**CWI Name:** See Below**CWI Present:** Yes No**Inspected CWI report:** Yes No N/A**Rod Oven in Use:** Yes No N/A**Electrode to specification:** Yes No N/A**Weld Procedures Followed:** Yes No N/A**Qualified Welders:** Yes No N/A**Verified Joint Fit-up:** Yes No N/A**Approved Drawings:** Yes No N/A**Approved WPS:** Yes No N/A**Delayed / Cancelled:** Yes No N/A**Bridge No:** 34-0006**Component:** OBG**Summary of Items Observed:**

WELDING INSPECTION REPORT

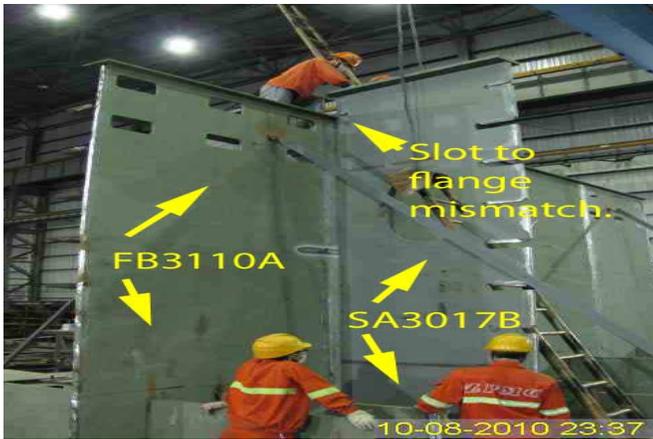
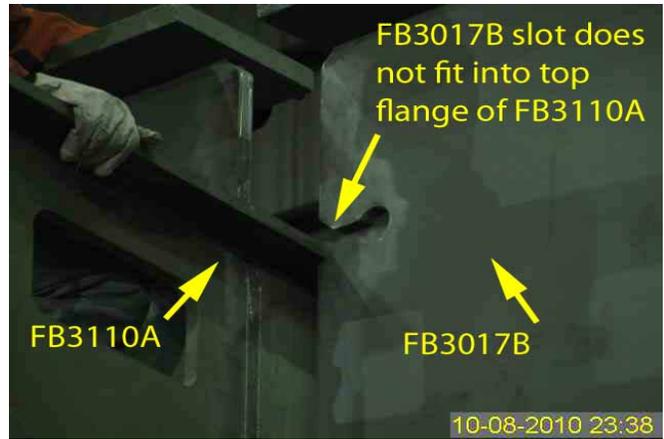
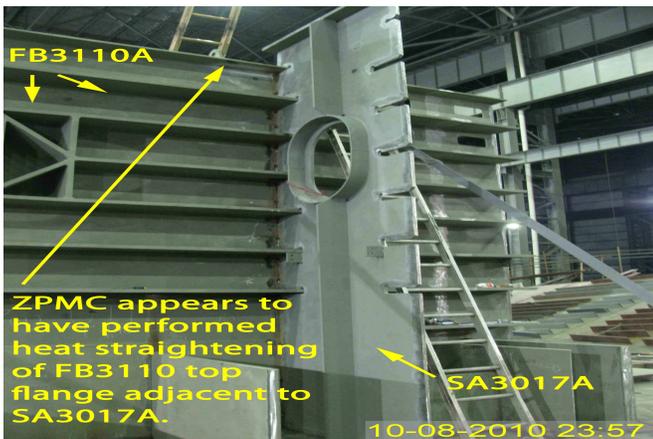
At around midnight ZPMC workers used an overhead crane to position OBG segment 13AE plate SA3017B in position adjacent to floor beam FB3110A. This QA Inspector observed the top flange of FB3110A appears to be distorted and the top flange would not fit into the slot cut into SA3017B. ABF CWI Mr. Mr. Zheng Qing Quan informed this QA Inspector that ZPMC needs to obtain a heat straightening approval and since no ZPMC QC is available to submit this document that no additional plates will be installed this shift. See the photographs below for additional information.
