DEPARTMENT OF TRANSPORTATION

Quality Assurance and Source Inspection

Contract #: 04-0120F4Cty: SF/ALA Rte: 80 PM: 13.2/13.9File #: 69.28**WELDING INSPECTION REPORT****Resident Engineer:** Siegenthaler, Peter**Address:** 333 Burma Road**City:** Oakland, CA 94607**Report No:** WIR-017308**Date Inspected:** 12-Oct-2010**Project Name:** SAS Superstructure**OSM Arrival Time:** 1900**Prime Contractor:** American Bridge/Fluor Enterprises, a JV**OSM Departure Time:** 700**Contractor:** Zhenhua Port Machinery Company, Ltd (ZPMC), Changxing Island **Location:** Shanghai, China**CWI Name:** See Below**CWI Present:** Yes No**Inspected CWI report:** Yes No N/A**Rod Oven in Use:** Yes No N/A**Electrode to specification:** Yes No N/A**Weld Procedures Followed:** Yes No N/A**Qualified Welders:** Yes No N/A**Verified Joint Fit-up:** Yes No N/A**Approved Drawings:** Yes No N/A**Approved WPS:** Yes No N/A**Delayed / Cancelled:** Yes No N/A**Bridge No:** 34-0006**Component:** OBG**Summary of Items Observed:**

WELDING INSPECTION REPORT

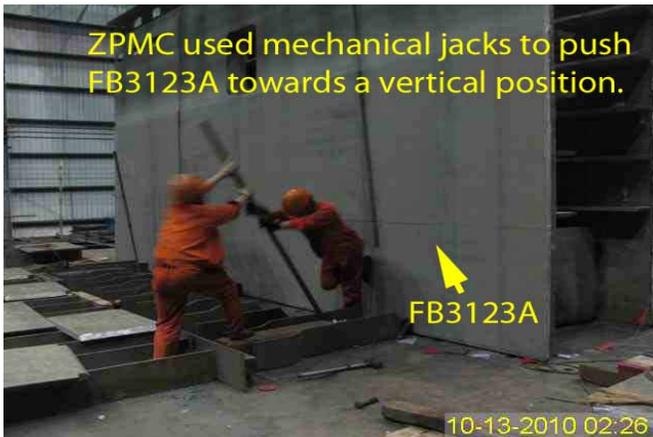
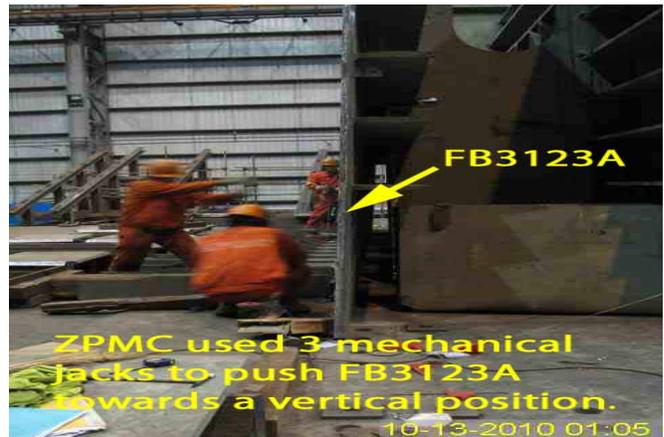
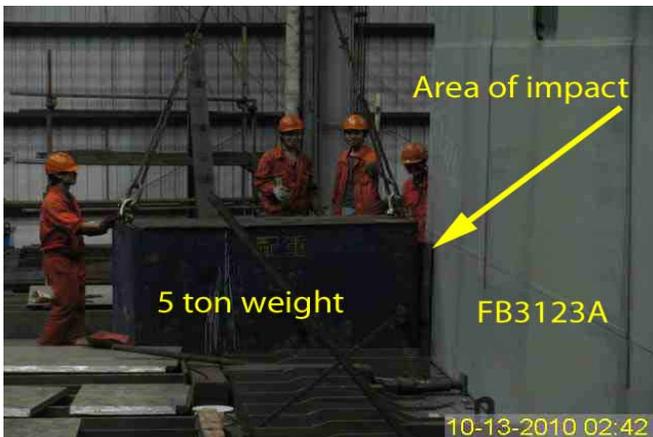
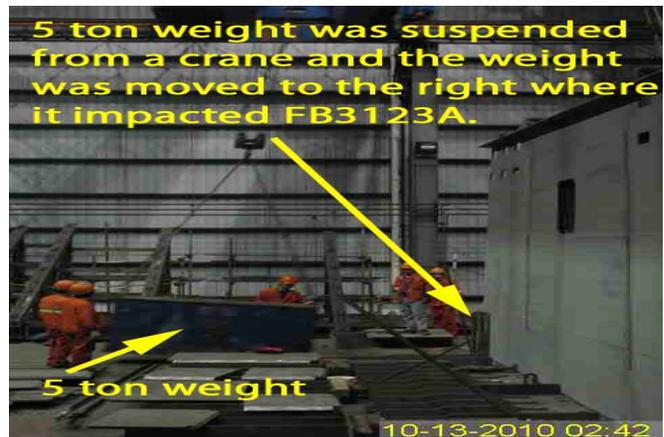
At around midnight ZPMC workers used an overhead crane to position OBG segment 13AE floor beam assembly FB3123B in position at panel point PP118.65. This QA Inspector observed ZPMC using three mechanical jacks to push the bottom of plate FB3123B towards a vertical position. The bottom of this floor beam scraped the bottom plate and ZPMC used a long extension bar to push the jacks in an attempt to align the floor beam. At around 0300 hours ZPMC placed wood blocks between the 5 ton weight and the floor beam. The 5 ton weight was attached to an overhead crane and the weight was used as a "hammer" to impact the bottom of FB3123B in an attempt to move the floor beam into a vertical position. This QA Inspector observed ZPMC performing this technique on the north end of FB3123B and ZPMC positioned the weight and wooden blocks on the south side, then the workers said they were going to stop working.

This QA Inspector observed ZPMC welder Mr. Xi Xianyou, stencil 047866 used shielded metal arc process to add additional weld material to two temporary lifting eyes on 14W bottom plate prior to the plate being lifted from the

transport vehicle at the back of bay 14. Due to recent rain, the top surface of the plate was wet and the welder did not appear to have any torch or other means of drying the steel prior to welding. This welder was only certified to perform FCAW welding and he is not certified to perform shielded metal arc welding. ABF representative Mr. Kelvin Cheung was contacted and he discussed this issue with the foreman. Mr. Kelvin Cheung said the lifting eyes were located in an area that will be trimmed off at a later time. This QA Inspector observed part of the lifting eyes extend in between stiffener plates. Items observed on this date do not appear to fully comply with applicable contract documents.
