Contract #: 04-0120F4Cty: SF/ALA Rte: 80 PM: 13.2/13.9File #: 82.28**WELDING INSPECTION REPORT****Resident Engineer:** Siegenthaler, Peter**Address:** 333 Burma Road**City:** Oakland, CA 94607**Report No:** WIR-017318**Date Inspected:** 05-Oct-2010**Project Name:** SAS Superstructure**Prime Contractor:** American Bridge/Fluor Enterprises, a JV**Contractor:** Westmont Industries**OSM Arrival Time:** 700**OSM Departure Time:** 1530**Location:** Santa Fe Springs, CA.

Traveler Test Rack

WELDING INSPECTION REPORT

SAS-EB Traveler

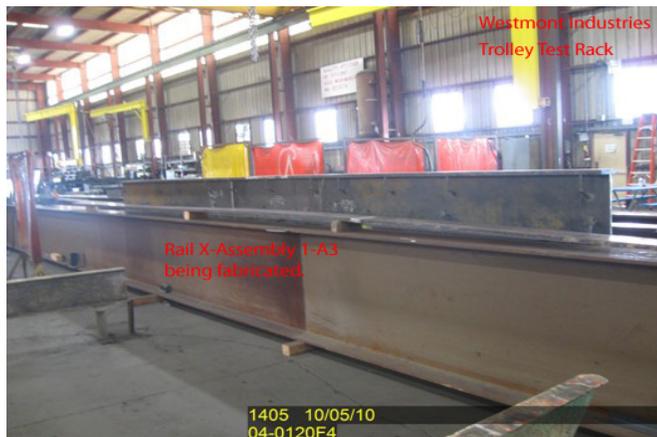
On this date, the QA Inspector observed production welder Larry Swanson and a helper perform fitting and tacking activities for the Trolley Test Stand. The QA Inspector observed that the activities were being performed on the piece mark identified as Rail X, Assembly 1-A3, per the shop drawings. The QA Inspector observed that this Rail X assembly consisted of a top and bottom flange and a web plate. The QA Inspector observed that Mr. Swanson was utilizing the overhead bay crane, chain and hook to lift the bottom flange and place flat on a piece of Wide Flange Beam (WFB) material, which is utilized for the fabrication of the Trolley Test Rack. Once the bottom flange was place, the QA Inspector observed that Mr. Swanson then lifted three sections of web plate material, utilizing the crane and then placed the material on the bottom flange. The QA Inspector observed that

the pieces of web plate material had been previously prepared, which appeared to a Complete Joint Penetration (CJP), 45 degree double bevel. Once the web plates were placed, the QA Inspector observed that the top Flange splice was then placed. The QA Inspector observed that temporary pieces of flat bar and angle iron were being utilized to fit and tack weld the Rail X flanges and web plates. Mr. Swanson explained that this material will be removed once the proper fit up and tacking activities are complete.

See attached picture below.

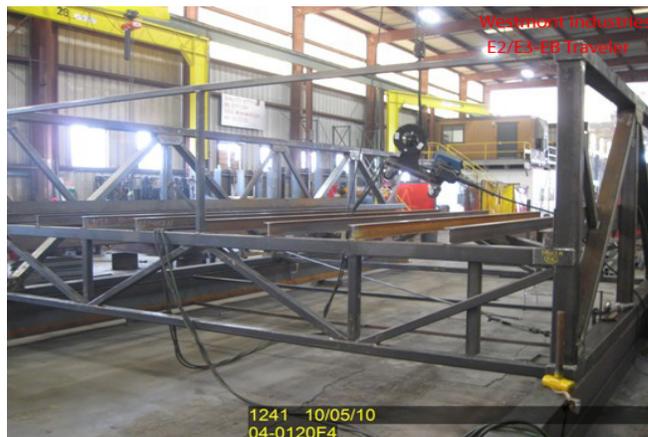
On this date, the QA Inspector observed Westmont Industries (WMI), production welder Raymundo Anaya and production fitter, Cesar Canales continuing to perform activities for the fabrication of the Travelers. The QA Inspector observed Mr. Anaya and Mr. Canales continue to fit up and FCAW tack weld the frame assemblies identified as A235, B235, A214 and A216. During the fit up and tack welding, the QA Inspector observed Mr. Anaya and Mr. Canales occasionally reference the shop drawings nearby the fabrication area to verify dimensions, prior to tacking. The QA Inspector observed that temporary pieces of angle iron were being tack welding in various locations to support the frame assemblies, during the fit up process. The QA Inspector observed that by the end of shift, Wide Flange Beam (WFB) material had been fit-up and tack welded in a perpendicular fashion to

the Frame assemblies identified as A214 and A216.

See attached picture below.
