Contract #: 04-0120F4Cty: SF/ALA Rte: 80 PM: 13.2/13.9File #: 82.28**WELDING INSPECTION REPORT****Resident Engineer:** Siegenthaler, Peter**Address:** 333 Burma Road**City:** Oakland, CA 94607**Report No:** WIR-017319**Date Inspected:** 06-Oct-2010**Project Name:** SAS Superstructure**OSM Arrival Time:** 700**Prime Contractor:** American Bridge/Fluor Enterprises, a JV**OSM Departure Time:** 1530**Contractor:** Westmont Industries**Location:** Santa Fe Springs, CA.**CWI Name:** R. Rodriguez, R. Dominguez**CWI Present:** Yes No**Inspected CWI report:** Yes No N/A**Rod Oven in Use:** Yes No N/A**Electrode to specification:** Yes No N/A**Weld Procedures Followed:** Yes No N/A**Qualified Welders:** Yes No N/A**Verified Joint Fit-up:** Yes No N/A**Approved Drawings:** Yes No N/A**Approved WPS:** Yes No N/A**Delayed / Cancelled:** Yes No N/A**Bridge No:** 34-0006**Component:** Travelers**Summary of Items Observed:**

Trolley Test Stand

SAS-EB Traveler

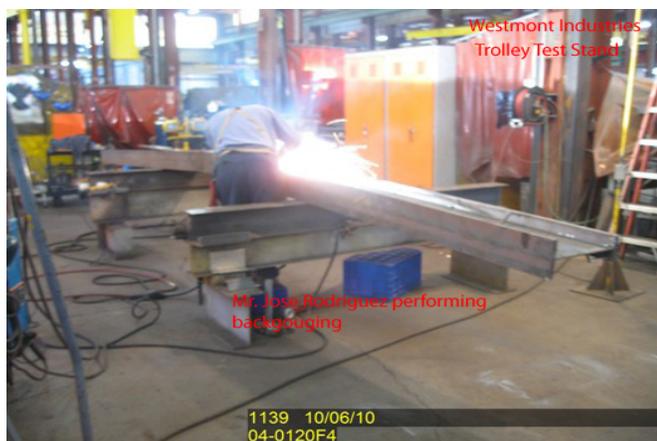
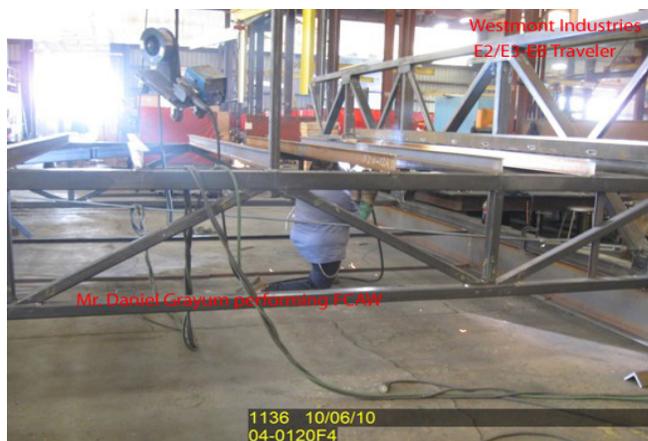
On this date, the QA Inspector observed Westmont Industries (WMI), production welder Jose Rodriguez (WID # 3031) performing Flux Core Arc Welding (FCAW) activities, for the Trolley Test Stand. The QA Inspector observed that Mr. Rodriguez was utilizing a Miller brand machine/wire feeder, to perform the FCAW and that Ultracore 71A85 (.045") diameter wire was being utilized, for the filler metal. The QA Inspector observed that Mr. Rodriguez was performing the FCAW in the 1G (flat) position and the fit up preparation appeared to be a Complete Joint Penetration (CJP), 45 degree double bevel. The QA Inspector observed that the FCAW was being performed on the piece mark identified as Rail X web splice, per the shop drawing # WMI-TTC-4 and Mr. Rodriguez appeared to be depositing the FCAW root pass. After the root pass was complete, the QA Inspector observed Mr. Rodriguez perform backgouging, utilizing the Carbon Arc process, to remove the root pass to sound metal.

On this date, the QA Inspector observed Westmont Industries (WMI), production welder Raymundo Anaya and production fitter, Cesar Canales continuing to perform activities for the fabrication of the Travelers. The QA Inspector observed Mr. Anaya and Mr. Canales continue to fit up and FCAW tack weld the frame assemblies identified as A235, B235, A214 and A216. During the fit up and tack welding, the QA Inspector observed Mr. Anaya and Mr. Canales occasionally reference the shop drawings nearby the fabrication area, to verify dimensions, prior to tacking. The QA Inspector observed that temporary pieces of angle iron were being tack welding in various locations to support the frame assemblies, during the fit up process. On this date, the QA Inspector observed Westmont Industries (WMI), production welder Daniel Grayum (WID # 3049), continuing to perform Flux Core Arc Welding (FCAW) activities for the E2/E3-EB Traveler frames. The QA Inspector observed Mr. Grayum performing the FCAW in the overhead position and the FCAW was being performed on the previously tack welded Wide Flange Beams (WFB's), to A214 and A216 Traveler Frame assemblies. The QA Inspector observed that Mr. Grayum was utilizing a Miller brand machine and wire feeder, to perform the FCAW and that Ultracore 71A85 (.045") diameter wire was being utilized, for the filler metal.

On this date, the QA Inspector observed Westmont Industries (WMI), production welder Eutimo Lopez (WID # 3035), continuing to perform Flux Core Arc Welding (FCAW) activities for the E2/E3-EB Traveler frames. The QA Inspector observed Mr. Lopez performing the FCAW on previously fit and tack welded Tube Steel (TS) on the Frame Assembly, identified as B237, per the shop drawings. The QA Inspector observed that Mr. Lopez was utilizing a Miller brand machine and wire feeder, to perform the FCAW and that Ultracore 71A85 (.045") diameter wire was being utilized, for the filler metal.
