Contract #: 04-0120F4Cty: SF/ALA Rte: 80 PM: 13.2/13.9File #: 82.28**WELDING INSPECTION REPORT****Resident Engineer:** Siegenthaler, Peter**Address:** 333 Burma Road**City:** Oakland, CA 94607**Report No:** WIR-017320**Date Inspected:** 07-Oct-2010**Project Name:** SAS Superstructure**OSM Arrival Time:** 700**Prime Contractor:** American Bridge/Fluor Enterprises, a JV**OSM Departure Time:** 1530**Contractor:** Westmont Industries**Location:** Santa Fe Springs, CA.**CWI Name:** R. Rodriguez, R. Dominguez**CWI Present:** Yes No**Inspected CWI report:** Yes No N/A**Rod Oven in Use:** Yes No N/A**Electrode to specification:** Yes No N/A**Weld Procedures Followed:** Yes No N/A**Qualified Welders:** Yes No N/A**Verified Joint Fit-up:** Yes No N/A**Approved Drawings:** Yes No N/A**Approved WPS:** Yes No N/A**Delayed / Cancelled:** Yes No N/A**Bridge No:** 34-0006**Component:** Travelers**Summary of Items Observed:**

WELDING INSPECTION REPORT

SAS-EB Traveler

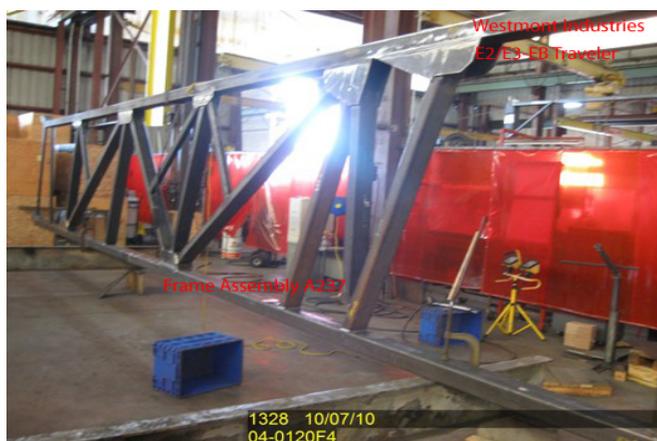
On this date, the QA Inspector observed Westmont Industries (WMI), production welder Daniel Grayum (WID # 3049), continuing to perform Flux Core Arc Welding (FCAW) activities for the E2/E3-EB Traveler. The QA Inspector observed Mr. Grayum performing the FCAW in various positions and the FCAW was being performed on the previously tack welded frame assemblies identified as A214, A216, A235 and B235. The QA Inspector observed that the welds were identified as fillet and flare groove and these frame assemblies appeared to be for the fabrication of the Elevated Truss Section of the Traveler, per the approved Shop Drawings. The QA Inspector observed that the FCAW was being performed on Tube Steel and Wide Flange Beam (WFB) material and that Mr. Grayum continued the FCAW throughout the end of shift.

See attached picture below.

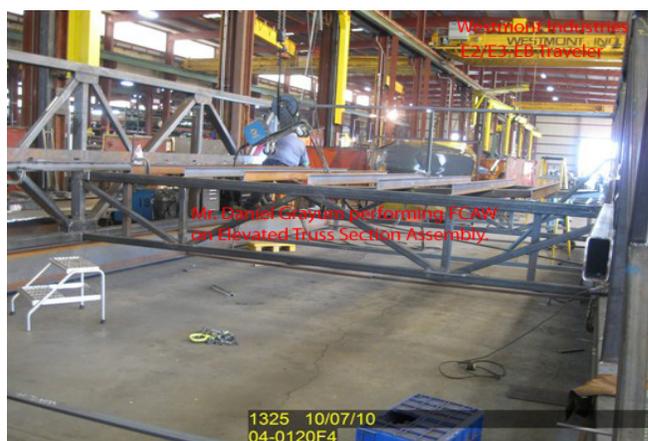
On this date, the QA Inspector observed Westmont Industries (WMI), production welder Eutimo Lopez (WID # 3035), continuing to perform Flux Core Arc Welding (FCAW) activities for the E2/E3-EB Traveler frames. The QA Inspector observed Mr. Lopez performing the FCAW on previously fit and tack welded Tube Steel (TS) and plate material, for the Frame Assembly identified as B237, per the shop drawings. The QA Inspector randomly observed that Mr. Lopez continued the FCAW throughout the end of the shift.

On this date, the QA Inspector observed Westmont Industries (WMI), production welder Juan Jimenez (WID # 3059), continuing to perform Flux Core Arc Welding (FCAW) activities for the E2/E3-EB Traveler frames. The QA Inspector observed Mr. Jimenez performing the FCAW on previously fit and tack welded Tube Steel (TS) and plate material, for the Frame Assembly identified as A237, per the shop drawings. The QA Inspector randomly observed that Mr. Jimenez continued the FCAW throughout the end of the shift.

See attached picture below.
